## Annual Inspection

Iwerne Minster Parish Council

Iwerne Minster Play Area

Watery Lane, Blandford Forum, DT11 8NB

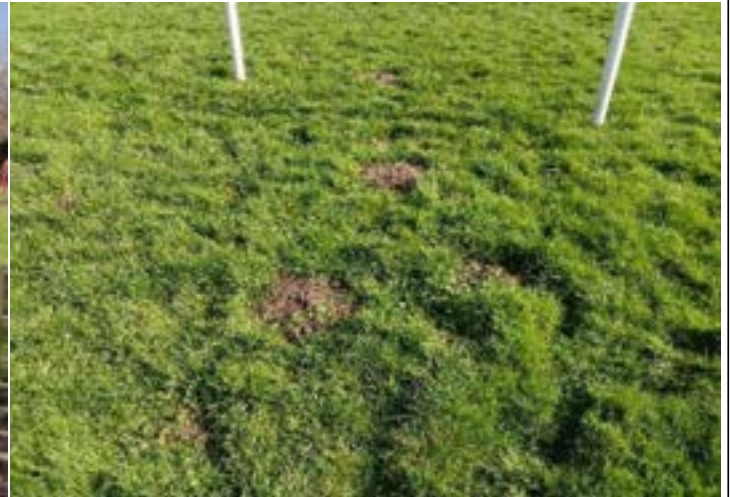
**Finding:** There are a number of molehills within the area and these may present unforeseen hazards for users

**Action:** Remove moles by appropriate means, reinstate surfaces to level and maintain the area

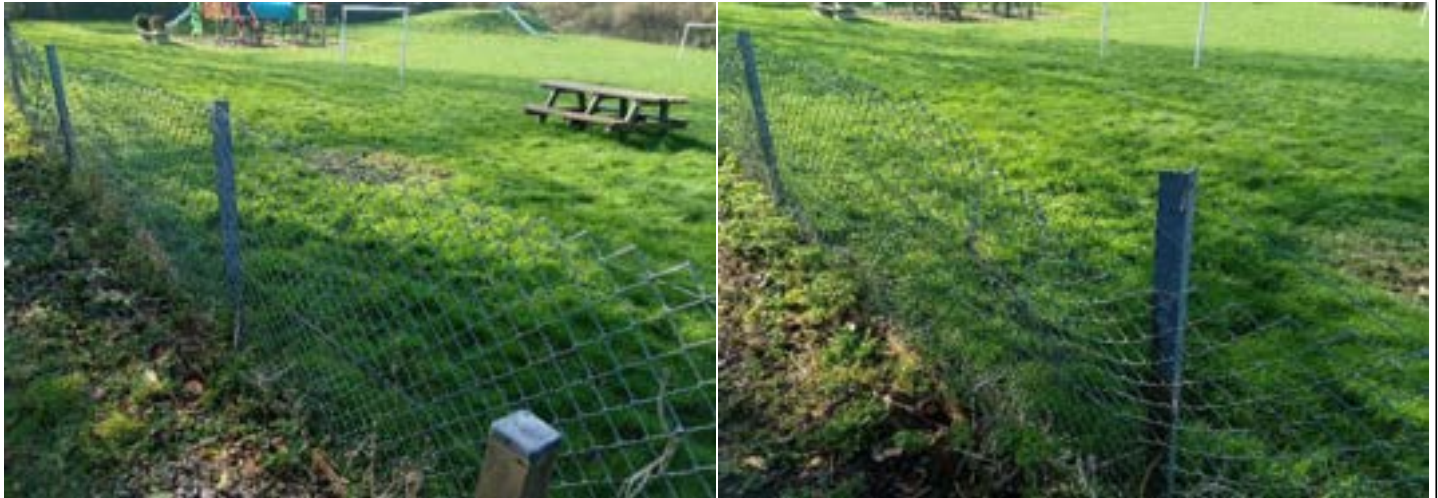
**Finding:** The fence is severely damaged in places

**Action:** Repair or replace all affected sections

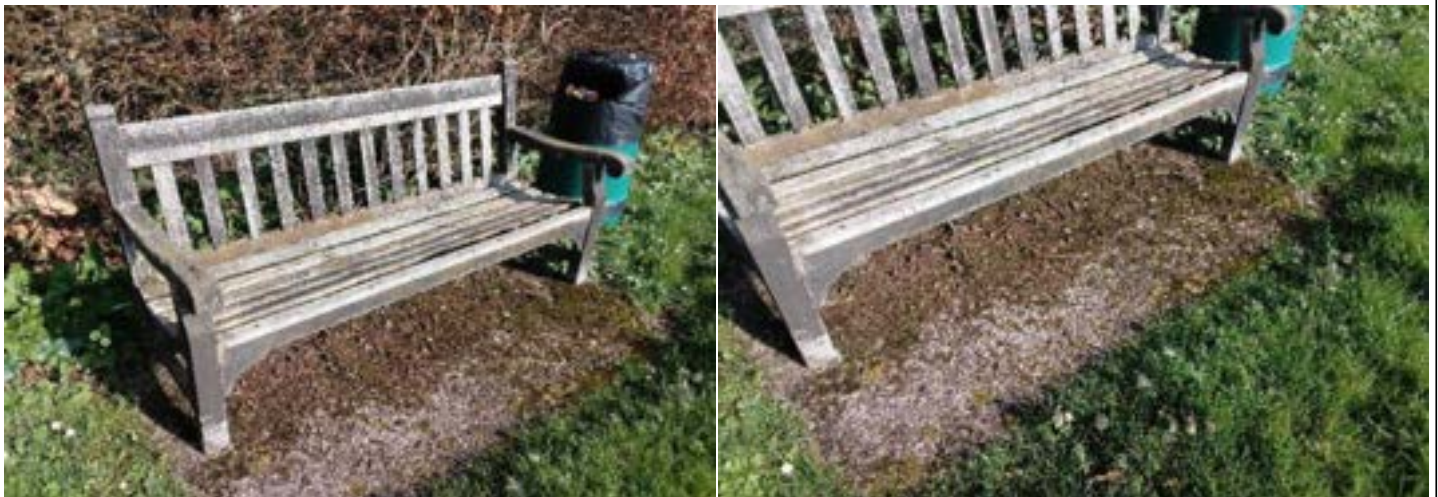
**Finding:** There is algae, silt or moss growth on the surface resulting in slippery conditions

**Action:** Clean and treat appropriately

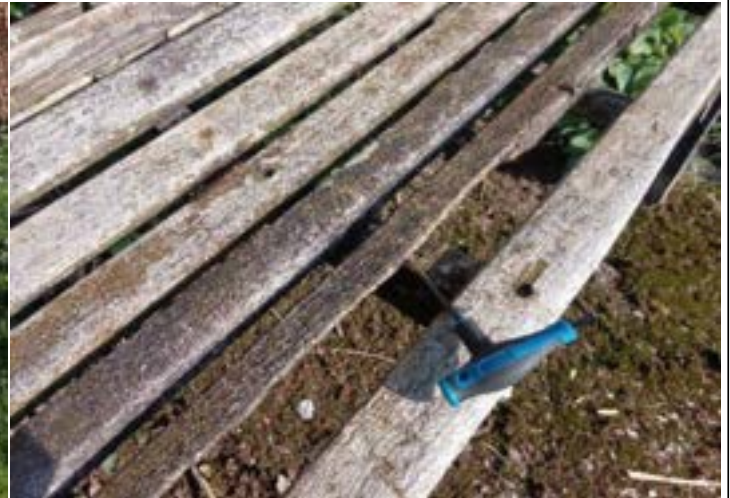
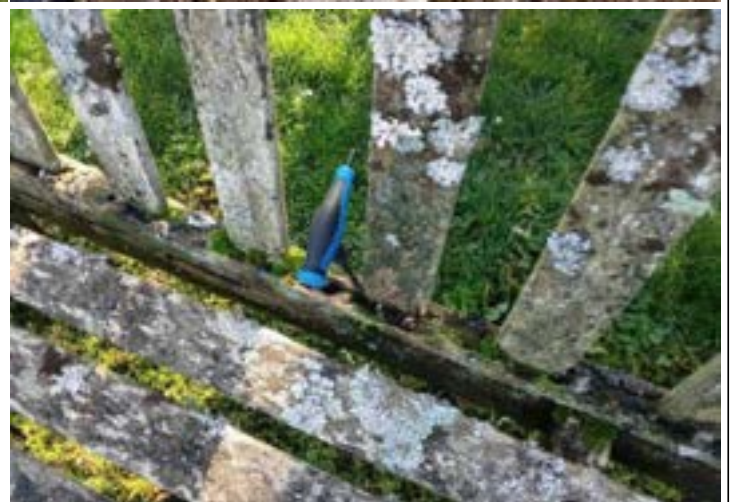
**Finding:** There are areas or parts of the timber on the structure that have rotted

**Action:** Replace all affected timbers

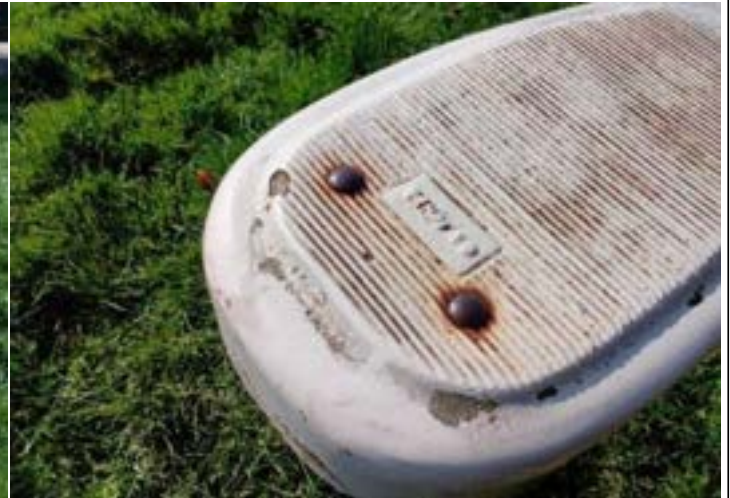
**Finding:** The seat has minor damage or wear

**Action:** Monitor for any further deterioration and replace as required

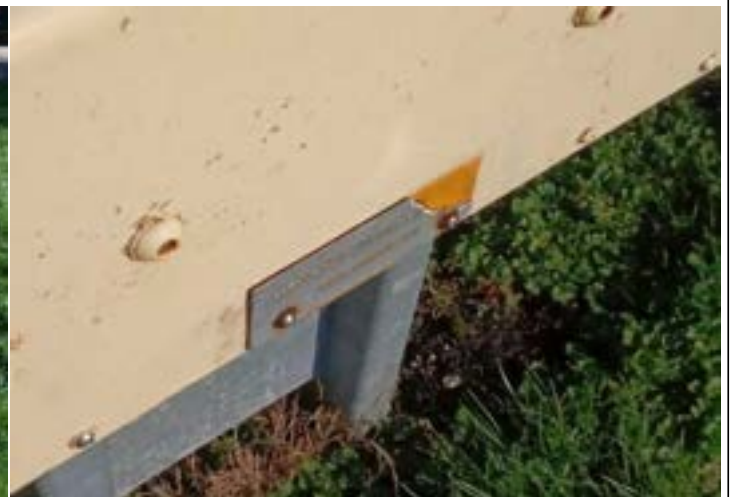
**Finding:** The signage is damaged

**Action:** Repacel

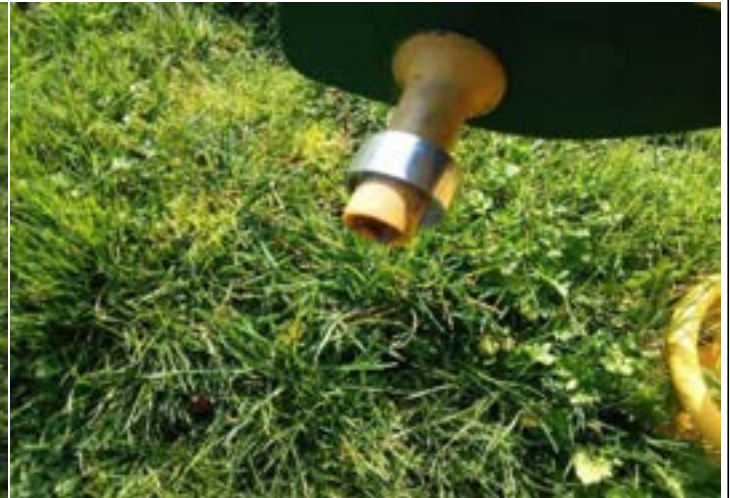
**Finding:** The end of handgrips and/or footrests have a cross section of less than 15cm² and fail to meet the requirements of BS EN 1176 Part 6  
**Action:** Monitor - No action given the risk assessment

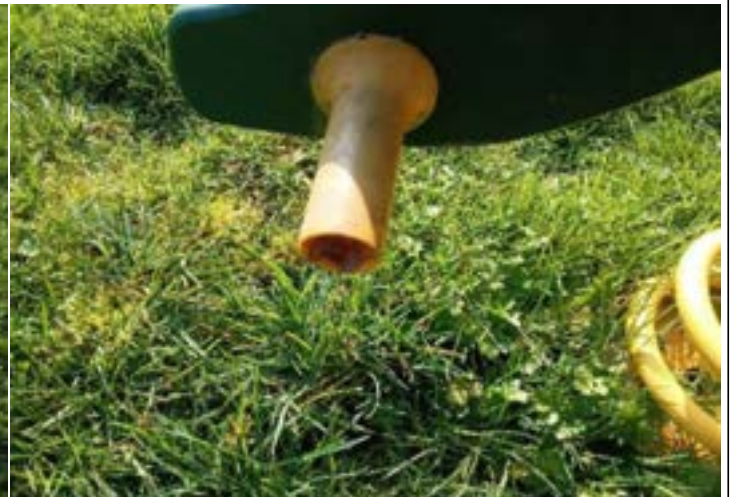
**Finding:** The end caps are missing on the Handgrips/Footrests

**Action:** Replace missing end caps

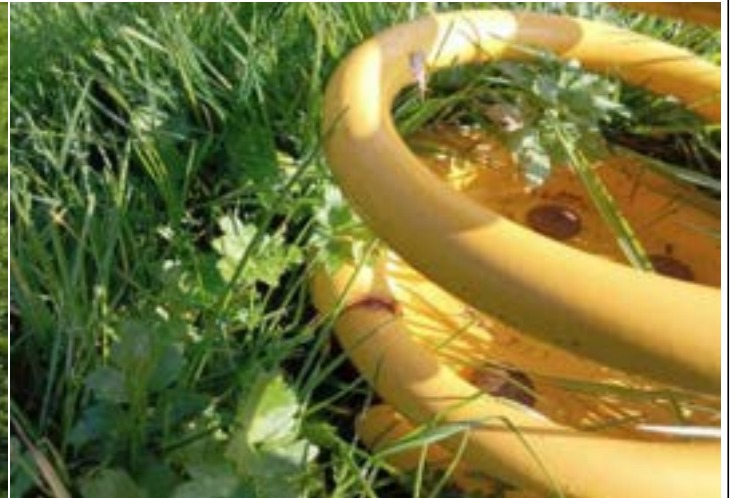
**Finding:** The paintwork on the spring has been damaged or worn exposing the metal underneath which is rusting  
**Action:** Treat any rusting components and repaint

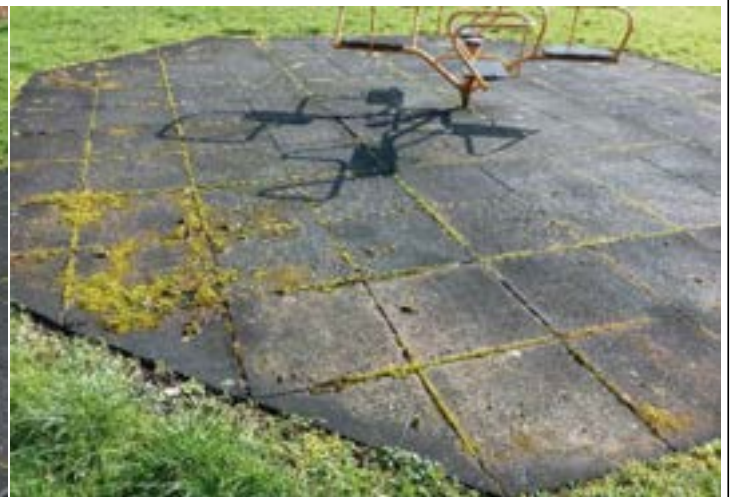
**Finding:** There is algae, silt or moss growth on the surface resulting in slippery conditions  
**Action:** Clean and treat appropriately

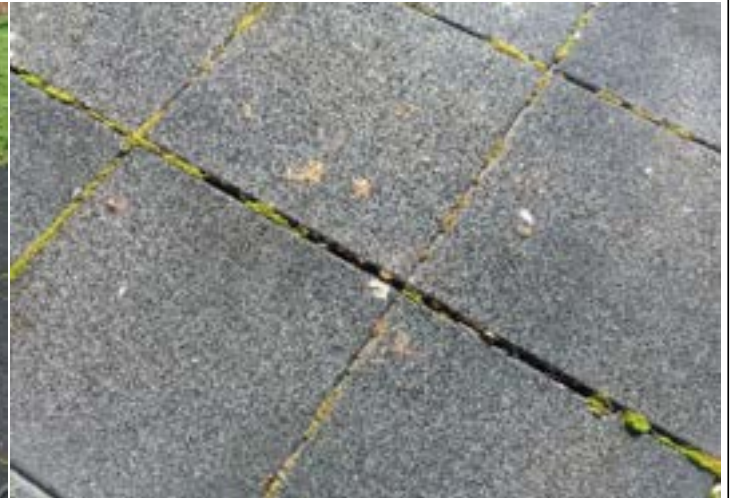
**Finding:** There are gaps opening in between the tiles

**Action:** Monitor for any further deterioration and repair as required

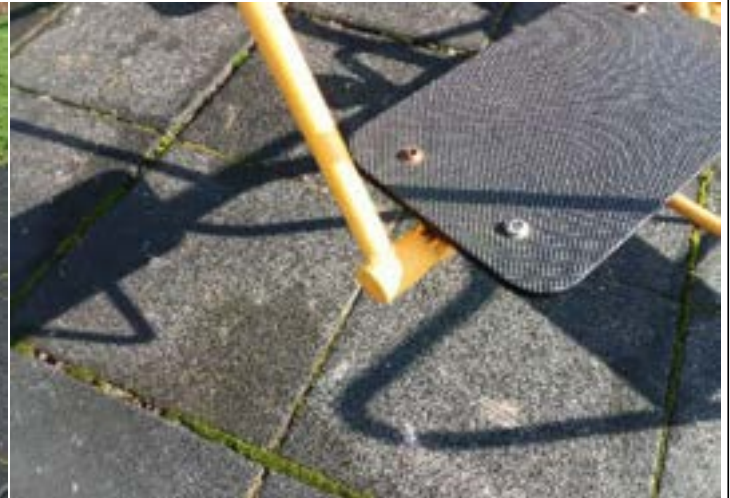
**Finding:** Parts of the steel structure protrude beyond the protected elements of the seat and fail to meet the requirements of BS EN 1176 Part 5

**Action:** Monitor - No action given the risk assessment

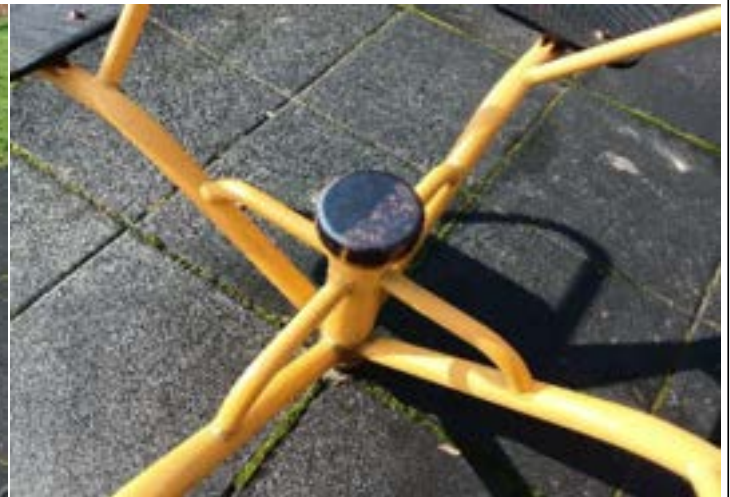
**Finding:** The bearing is showing signs of wear

**Action:** Monitor for any further deterioration and replace as required

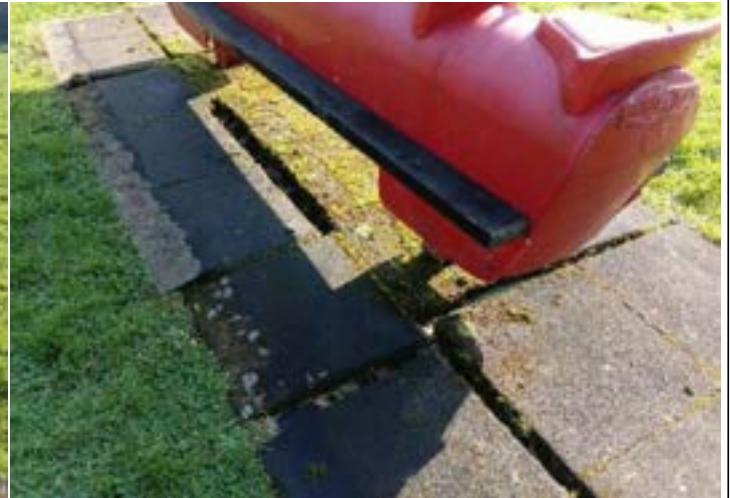
**Finding:** There are significant gaps (over 30mm) between the tiles; these are large enough for a small foot to enter

**Action:** Repair surfacing

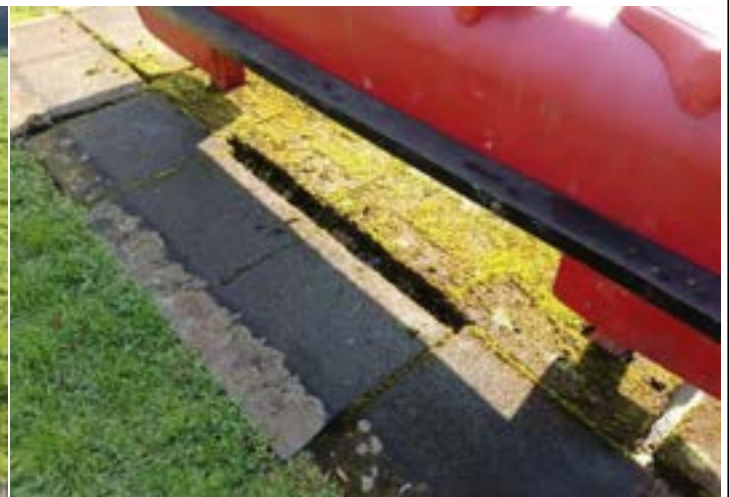
**Finding:** There is algae, silt or moss growth on the surface resulting in slippery conditions

**Action:** Clean and treat appropriately

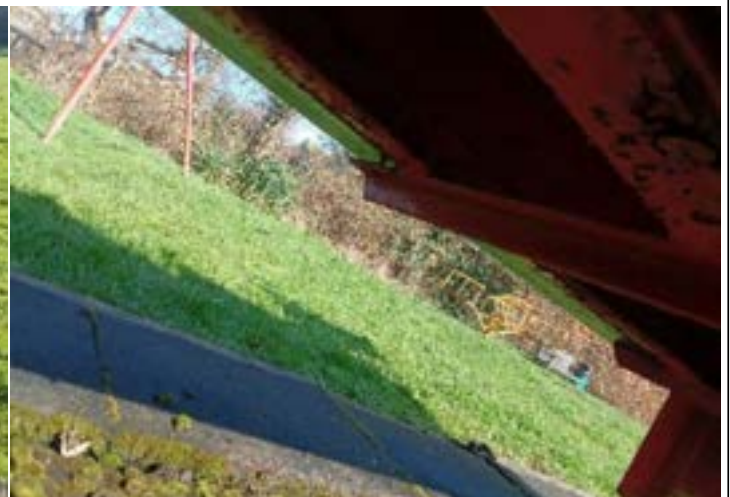
**Finding:** There is no gaiter protection for accessible moving parts (possible shear trap) as recommended in BS EN 1176 Part 1; 4.2.6 Moving Parts  
**Action:** Monitor - No action given the risk assessment

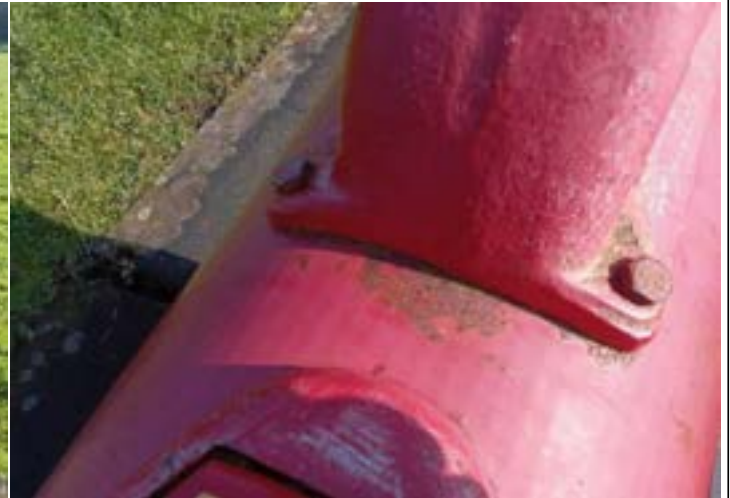
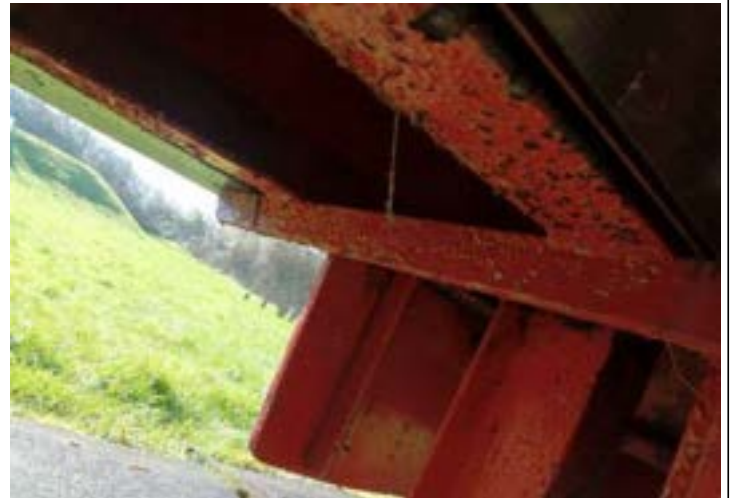
**Finding:** The paintwork on this item has been damaged or worn exposing the metal underneath which is rusting / corroding

**Action:** Treat affected areas and repaint

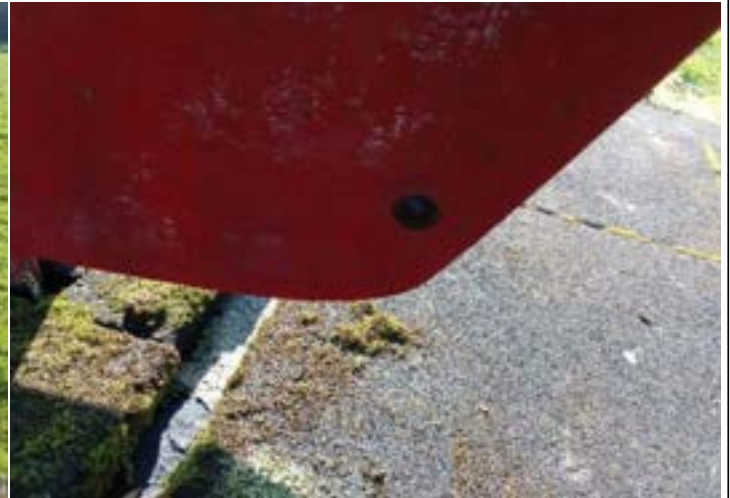
**Finding:** The fixings have corroded excessively

**Action:** Replace all corroded fixings

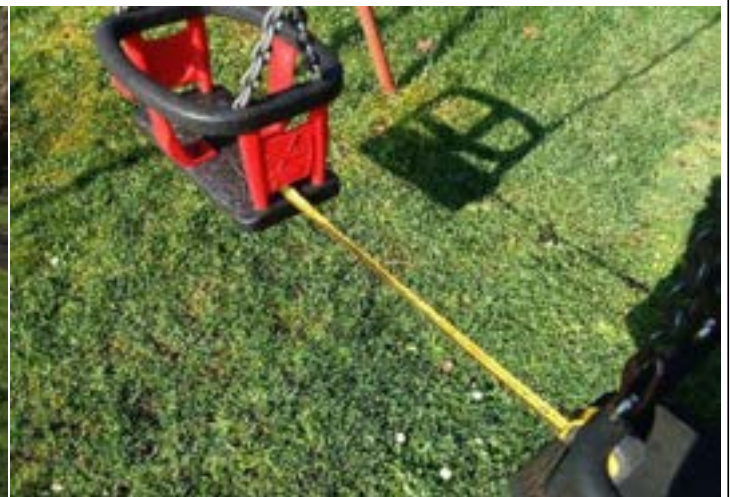
**Finding:** The seats are too close to each other as defined in BS EN 1176 Part 2; this is a low risk failure and no remedial action is required

**Action:** Monitor - No action given the risk assessment

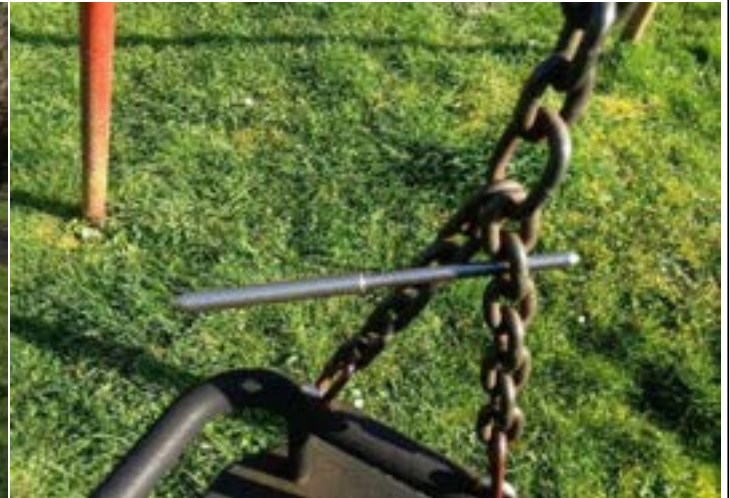
**Finding:** The chain openings are in excess of the 8.6mm as recommended by BS EN 1176  
**Action:** Monitor - No action given the risk assessment

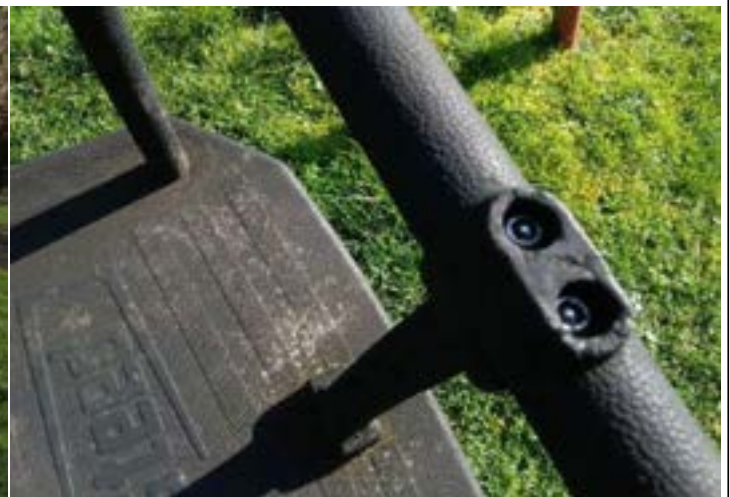
**Finding:** The seat has minor damage or wear  
**Action:** Monitor for any further deterioration and replace as required

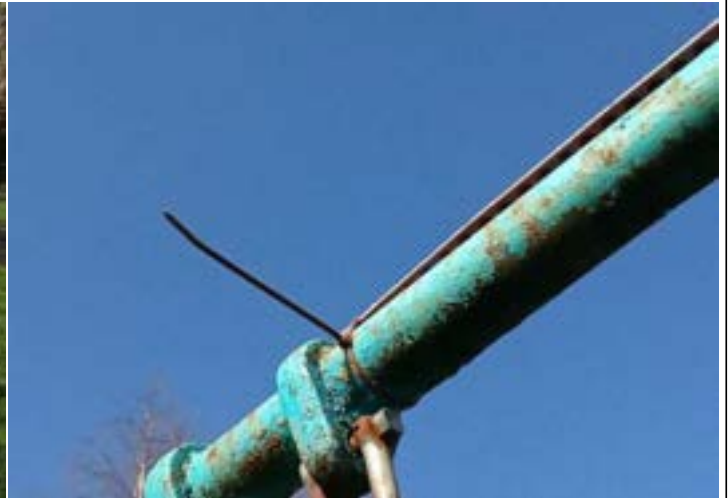
**Finding:** The bush / bushes is / are showing signs of wear

**Action:** Monitor for any further deterioration and replace as required

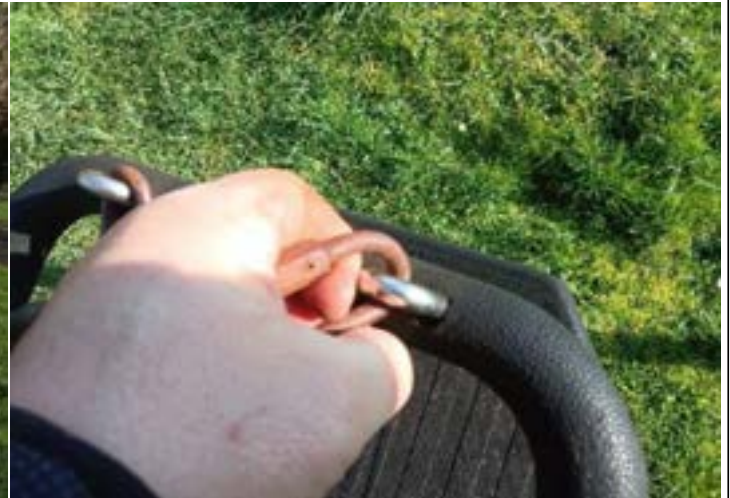
**Finding:** There is some wear to the connecting links

**Action:** Monitor for any further deterioration and replace when 40% worn

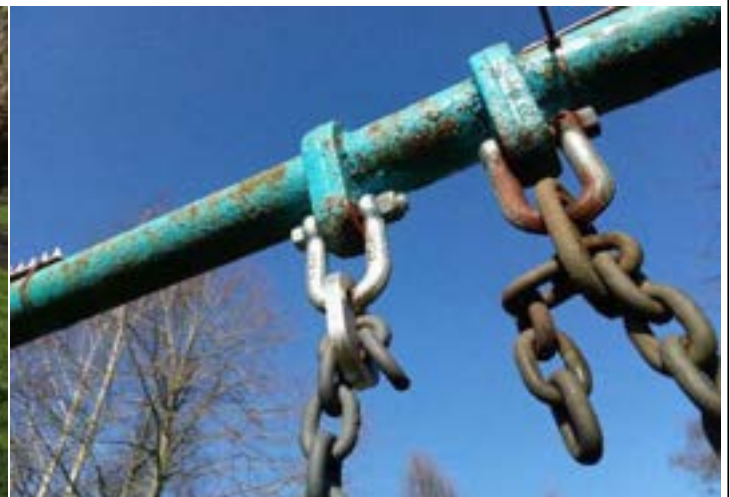
**Finding:** Crucifix or T connectors should have at least two complete chain links through the connector to meet with the manufacturers recommendations

**Action:** Rectify installation to ensure at least two complete links are through the connectors

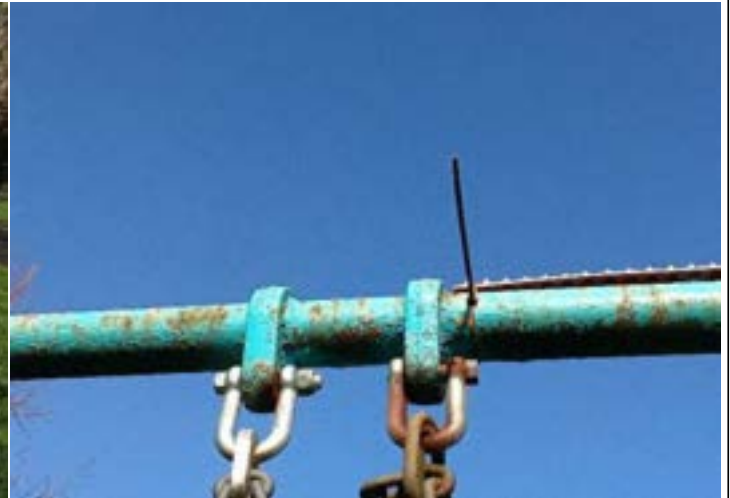
**Finding:** The paintwork on this item has been damaged or worn exposing the metal underneath which is rusting / corroding

**Action:** Treat affected areas and repaint

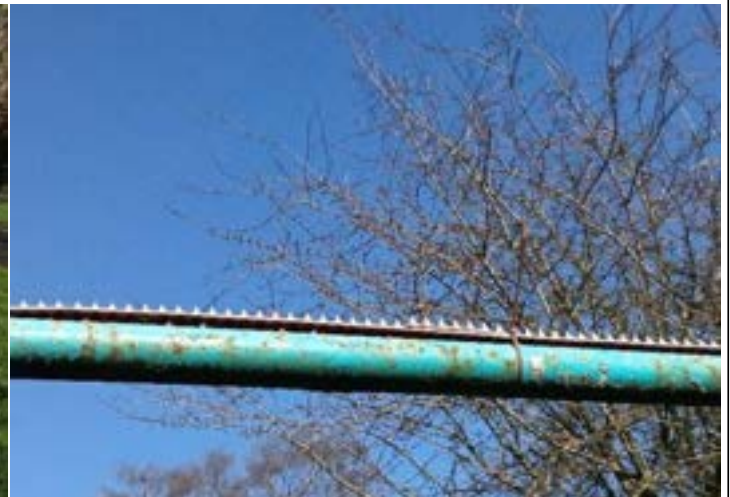
**Finding:** Bird deterrents have been fitted to the crossbar

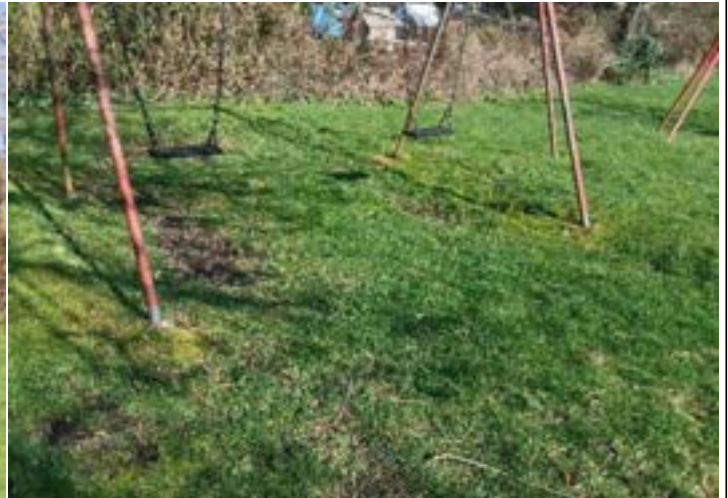
**Finding:** The depth of the loose fill surfacing is lower than the recommended depth specified in BS EN 1176; the free height of fall of the equipment is less than 2.0m and a minimum of 300mm depth should be provided (including an extra 100mm to allow for compaction and displacement as per BS EN 1176 Part 1 - Table 4)

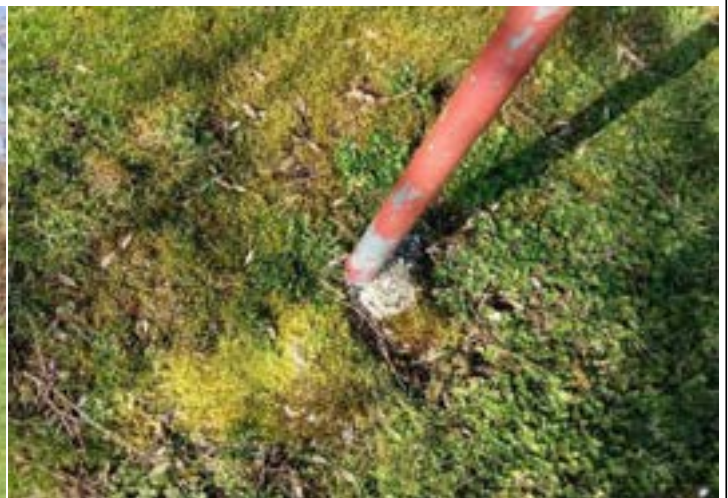
**Finding:** The surface has eroded and the foundations are exposed

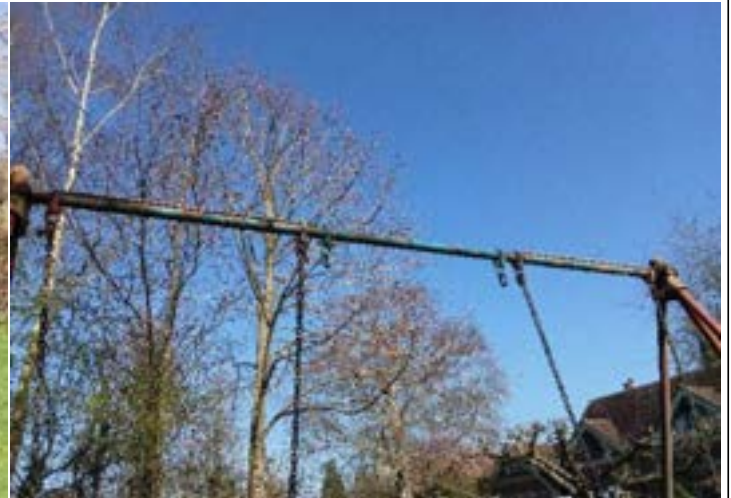
**Finding:** NOTE - The fixings or components for this item were in excess of 2.5m above the standing surface and could not be fully accessed by the inspector. We have completed a visual inspection of the fixings from ground level but a maintenance inspection should be undertaken to assess the condition, security and wear of the components at intervals in accordance with the manufacturers recommendations.

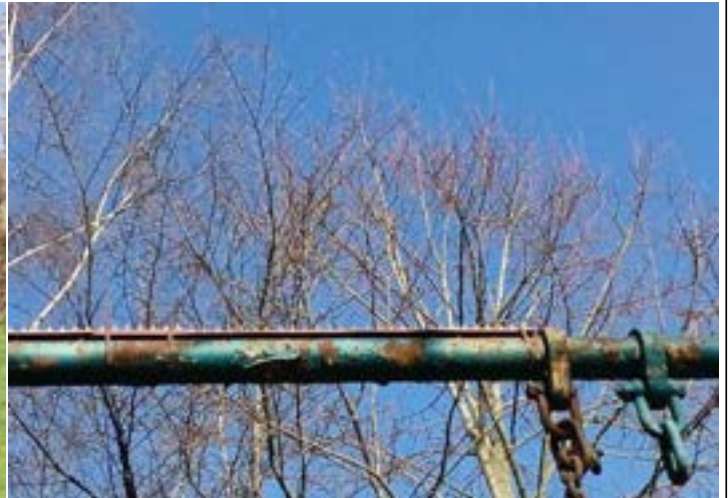
**Finding:** The paintwork on this item has been damaged or worn exposing the metal underneath which is rusting / corroding

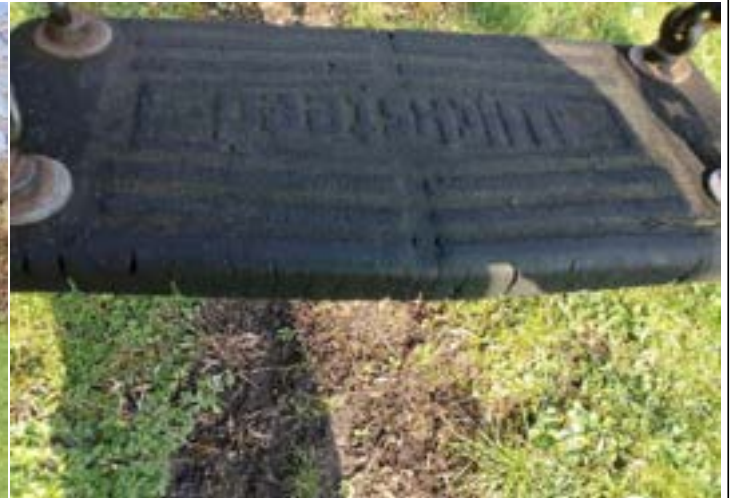
**Finding:** The seat has minor damage or wear

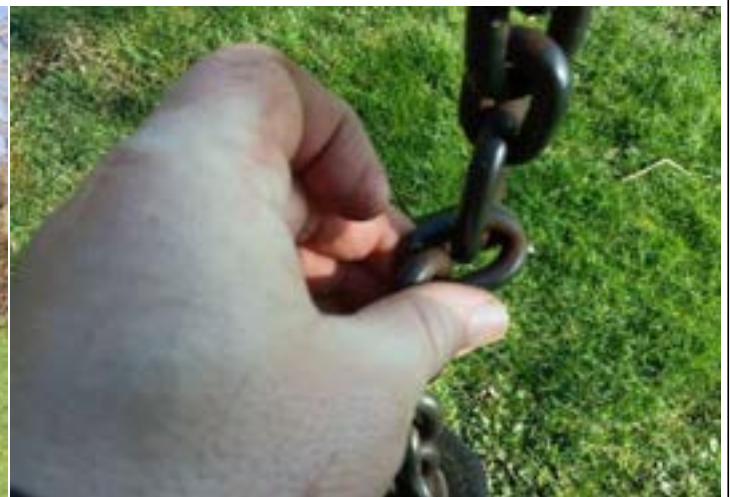
**Finding:** There is some notable evidence of chain wear

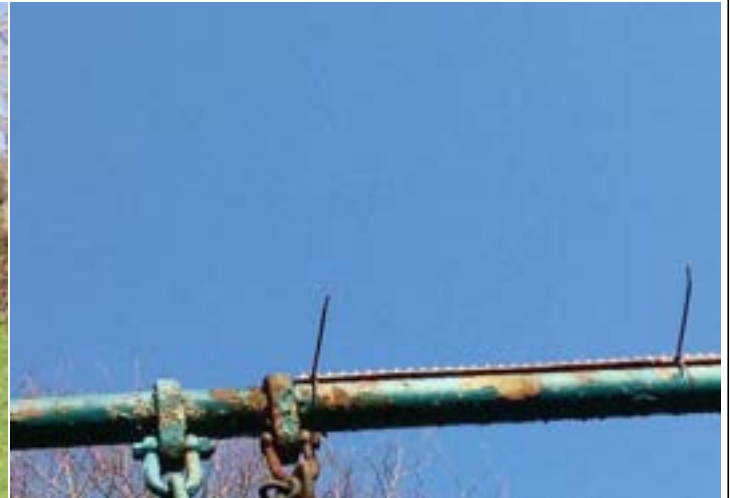
**Finding:** There is some wear to the shackles.

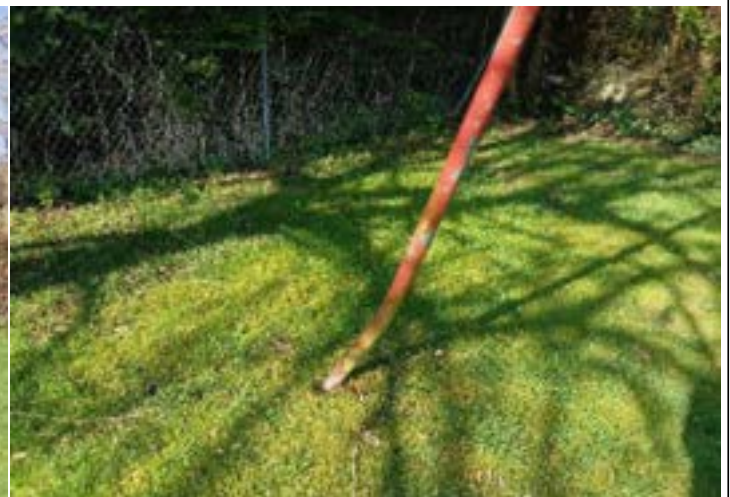
**Finding:** The framework has been damaged

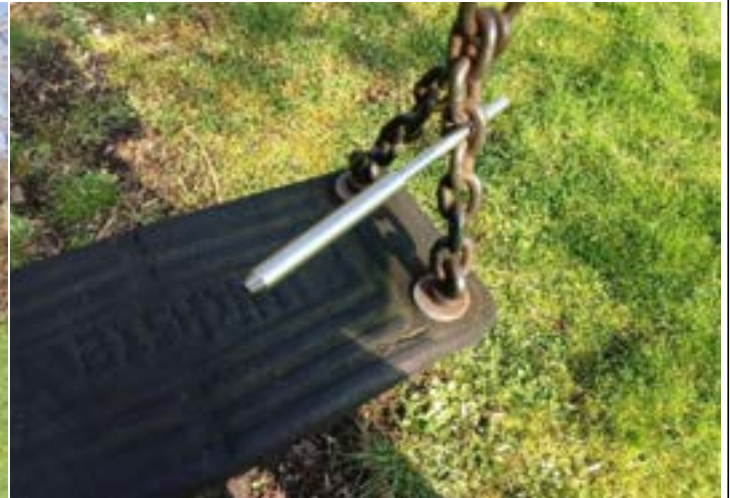
**Finding:** The chain openings are in excess of the 8.6mm as recommended by BS EN 1176  
**Action:** Monitor - No action given the risk assessment

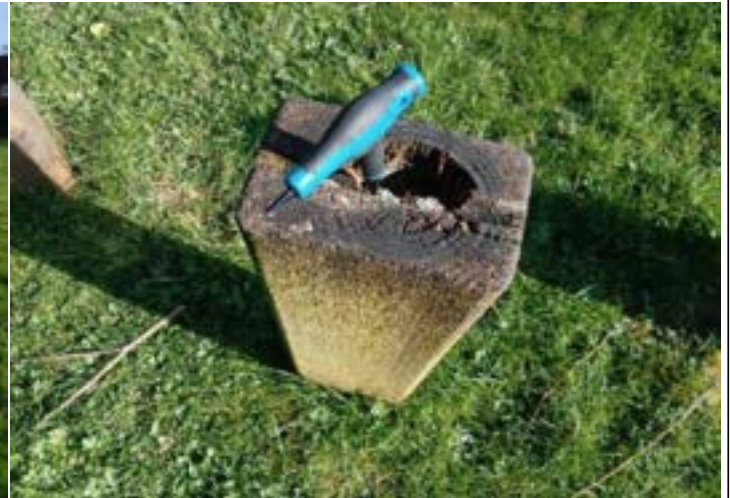
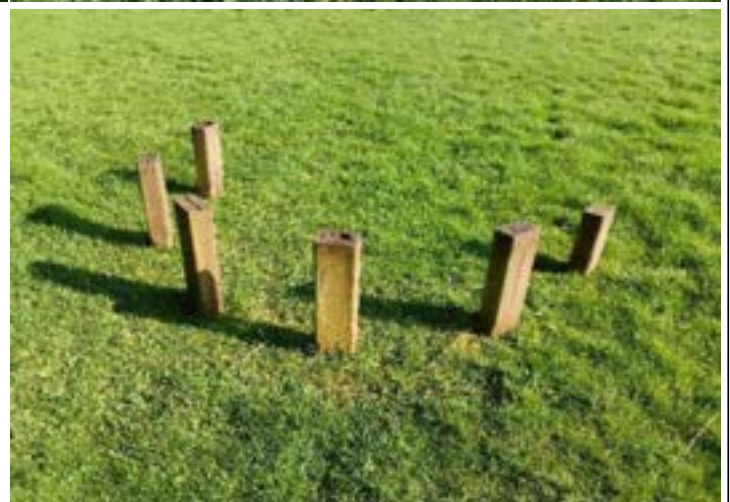
**Finding:** There are areas or parts of the stepping posts that have rotted  
**Action:** Replace all affected timbers

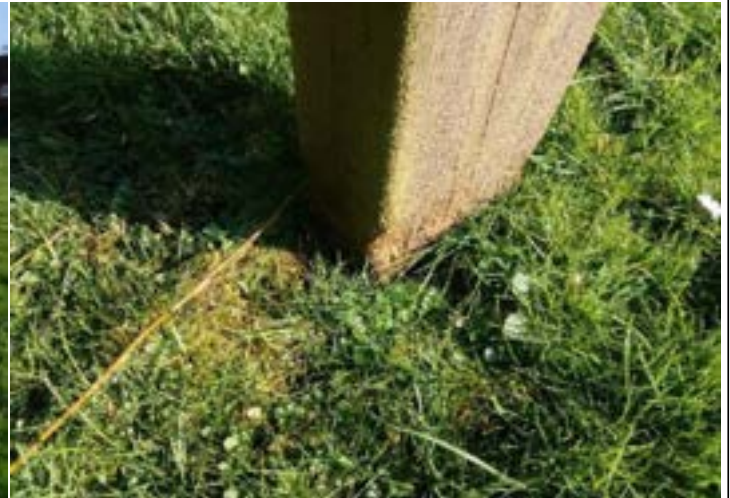
**Finding:** The timber stain is in poor condition

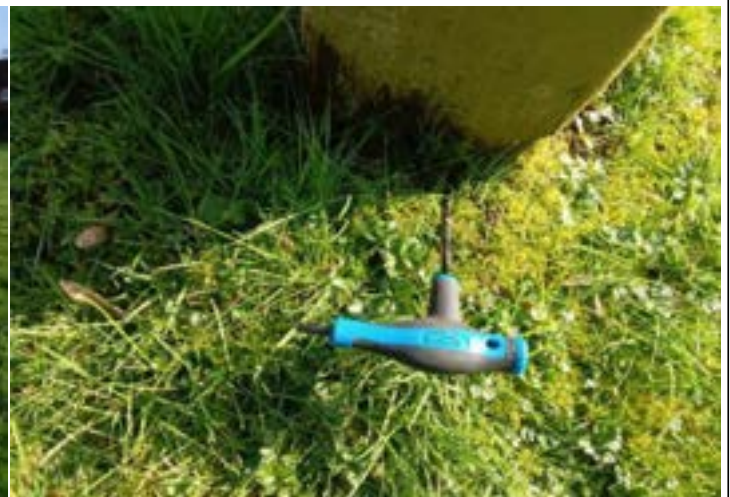
**Finding:** There is some evidence of rot in the timber

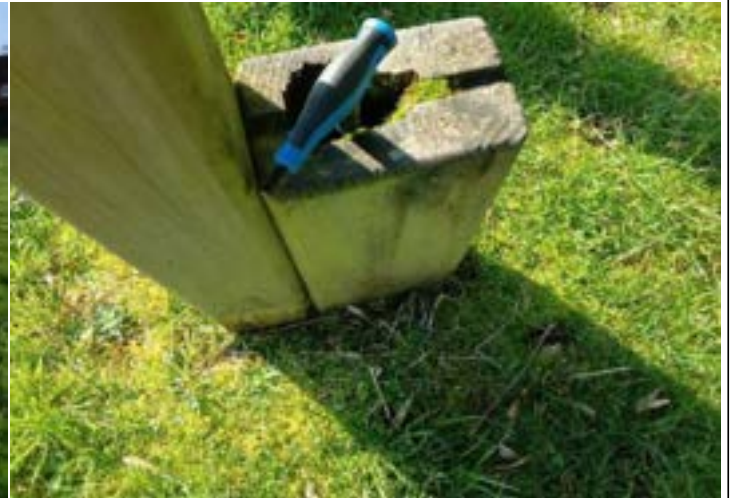
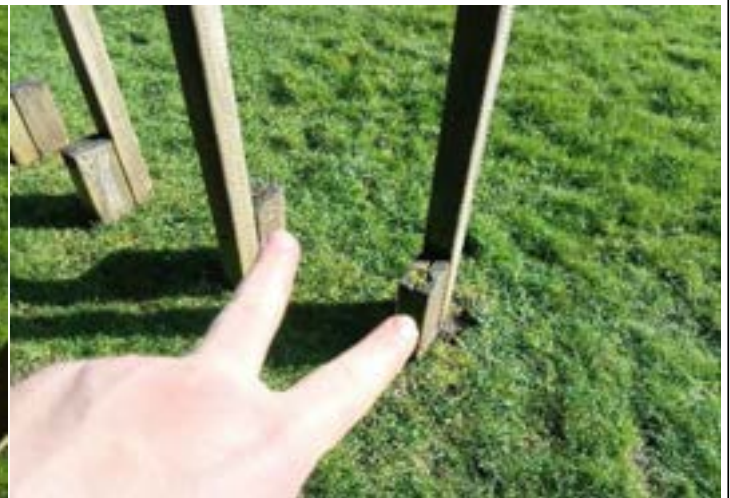
**Finding:** There are areas or parts of the stilts that have rotted

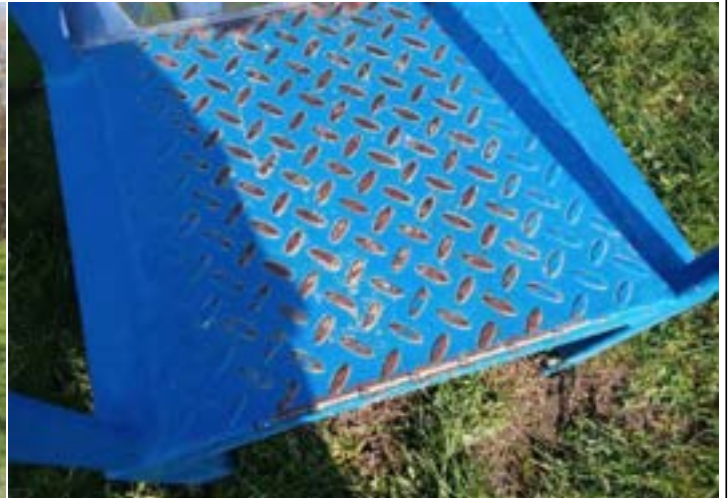
**Finding:** The paintwork on this item has been damaged or worn exposing the metal underneath which is rusting / corroding

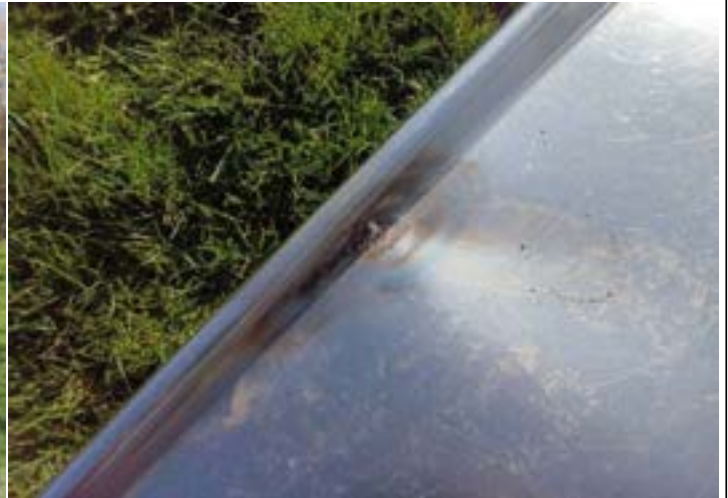
**Finding:** There is some evidence of fire damage to the item (potentially from a weld repair) **Action:** Monitor for any further deterioration and repair as required

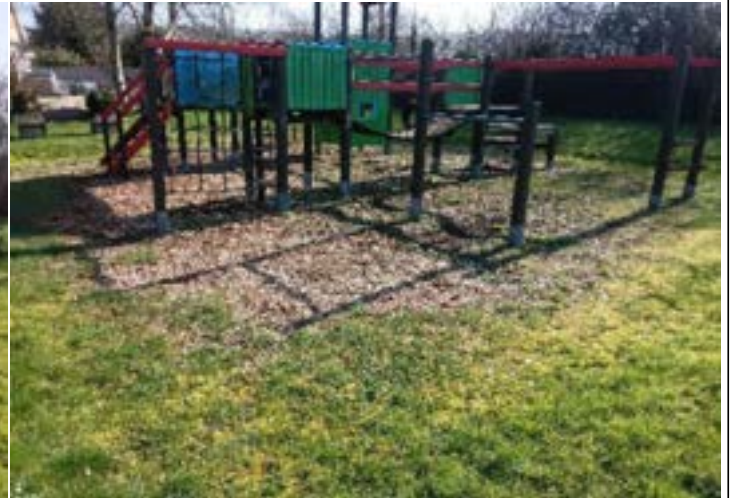
**Finding:** The depth of the loose fill surfacing is lower than the recommended depth specified in BS EN 1176; the free height of fall of the equipment is less than 2.0m and a minimum of 300mm depth should be provided (including an extra 100mm to allow for compaction and displacement as per BS EN 1176 Part 1 - Table 4)

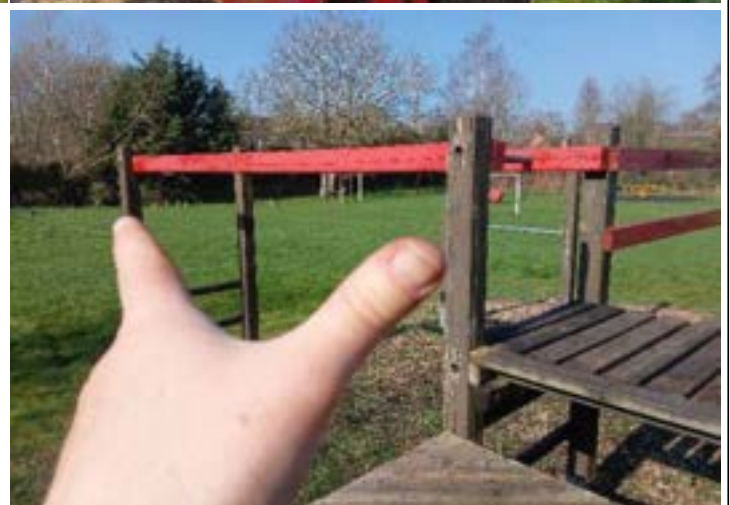
**Finding:** There are areas or parts of the posts x2 on the monkey bars that have rotted

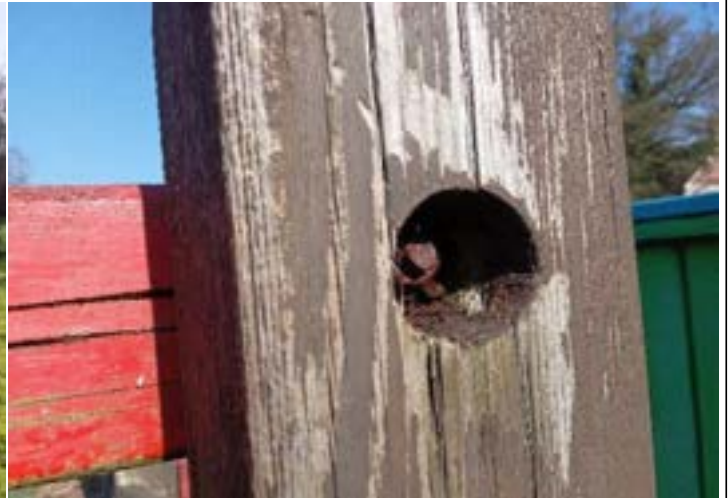
**Finding:** The fixings have corroded excessively

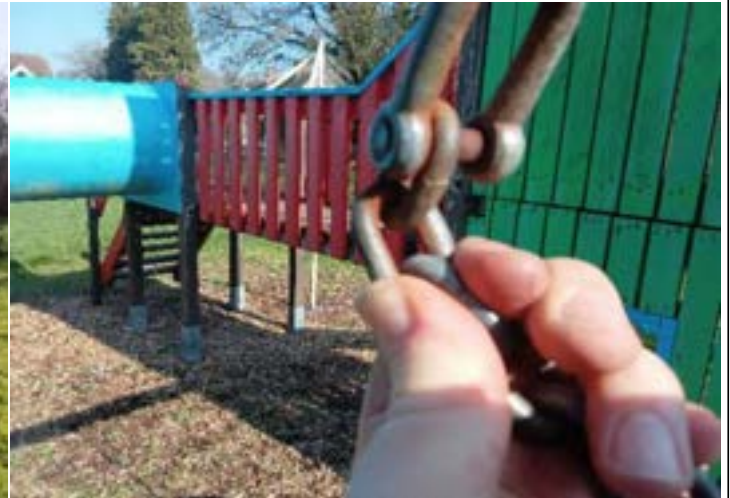
**Finding:** There is some notable evidence of chain wear

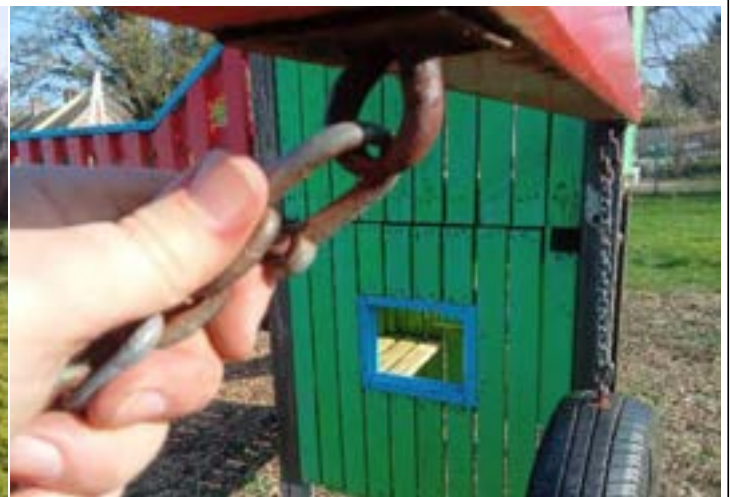
**Finding:** The connecting lugs are showing signs of wear

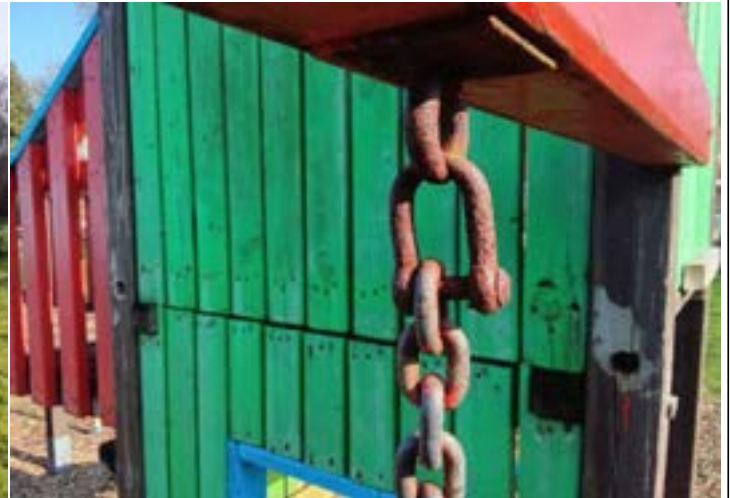
**Finding:** The shackles have corroded excessively

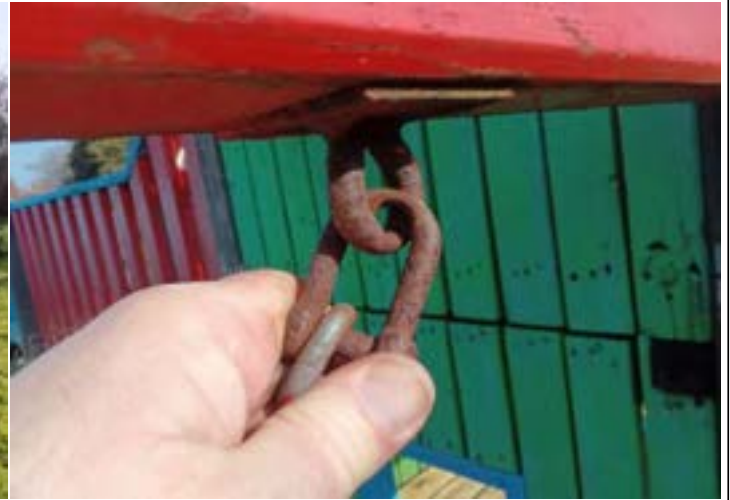
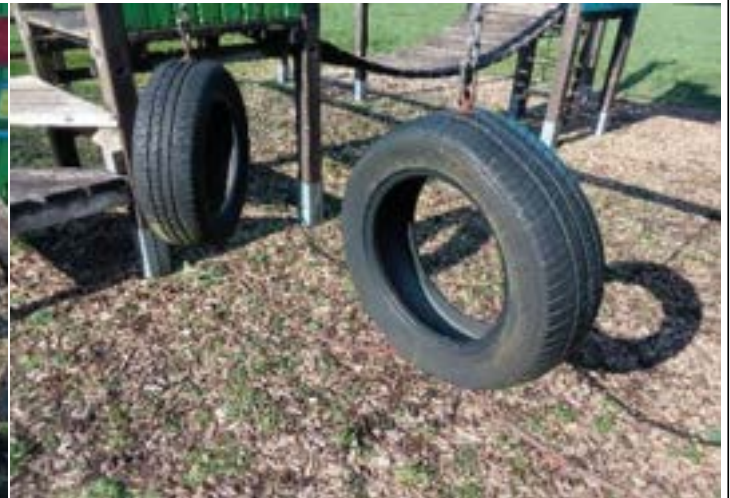
**Finding:** The shackles are worn in excess of 40% and require renewing

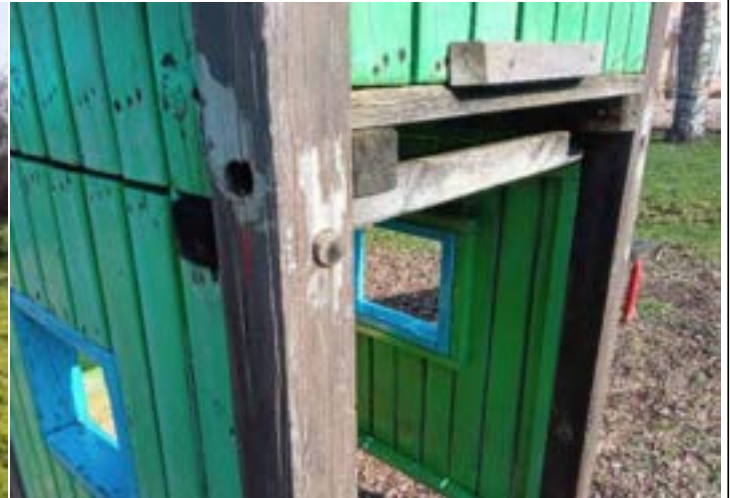
**Finding:** The timber stain is in poor condition

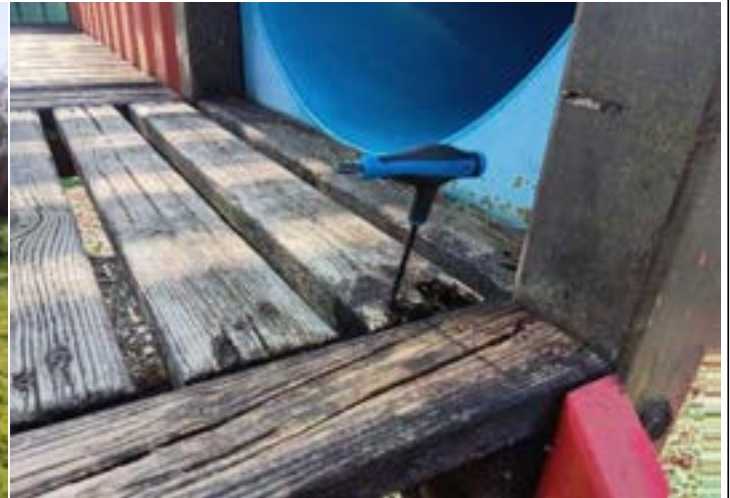
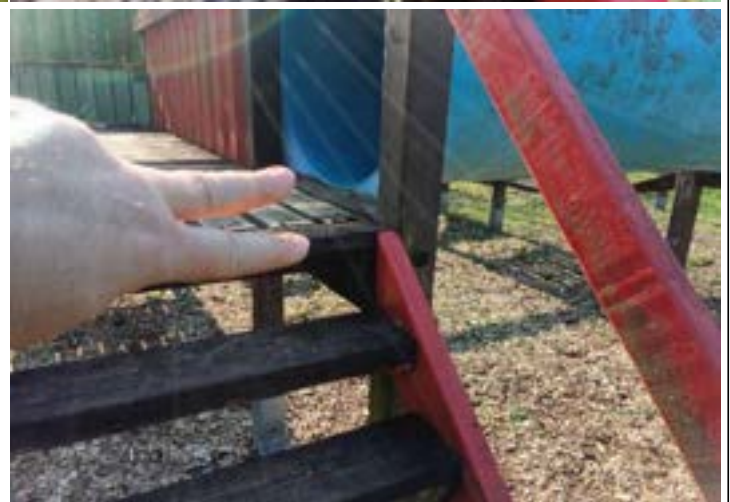
**Finding:** There are areas or parts of the platform that have rotted
