## Annual Inspection

Iwerne Minster Parish Council

Iwerne Minster Play Area

Watery Lane, Blandford Forum, DT11 8NB

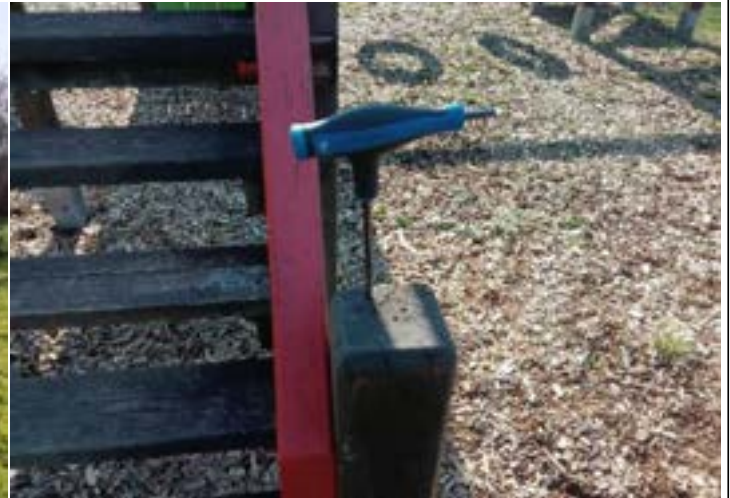
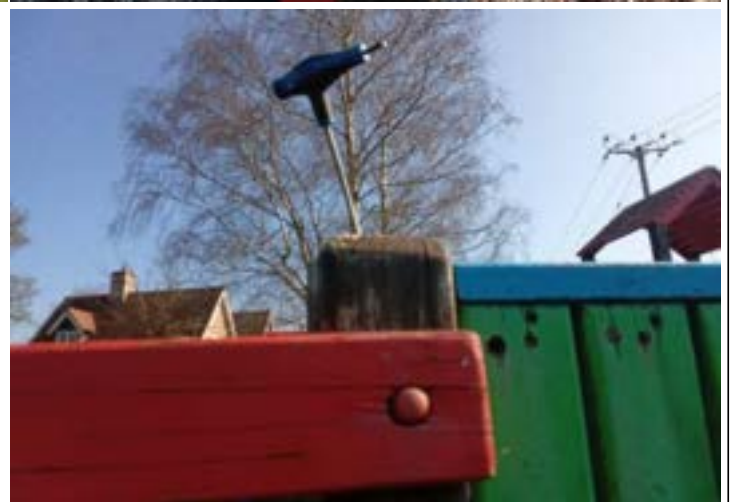
**Finding:** There is some evidence of rot in the posts

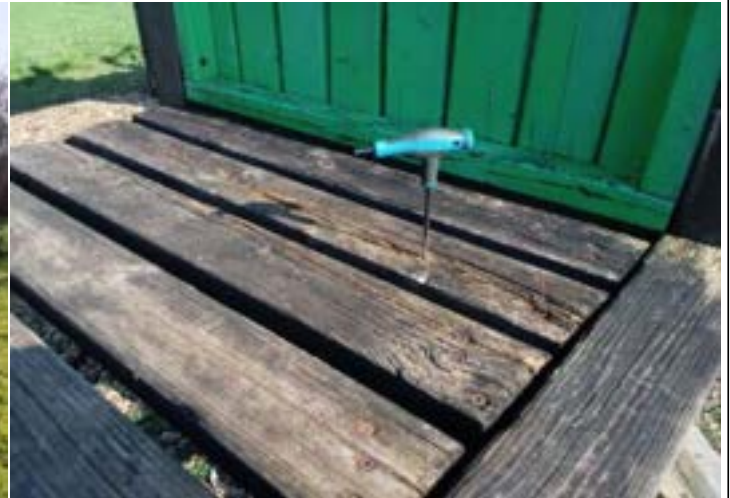
**Finding:** There is some evidence of rot in the platforms

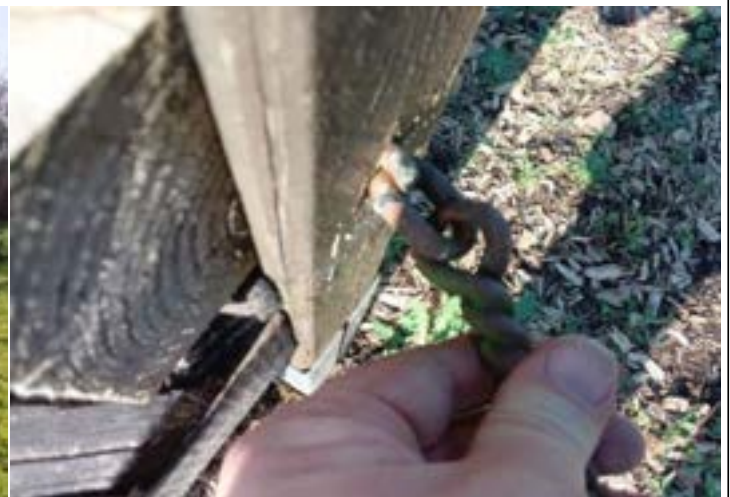
**Finding:** There is some wear to the chain bars

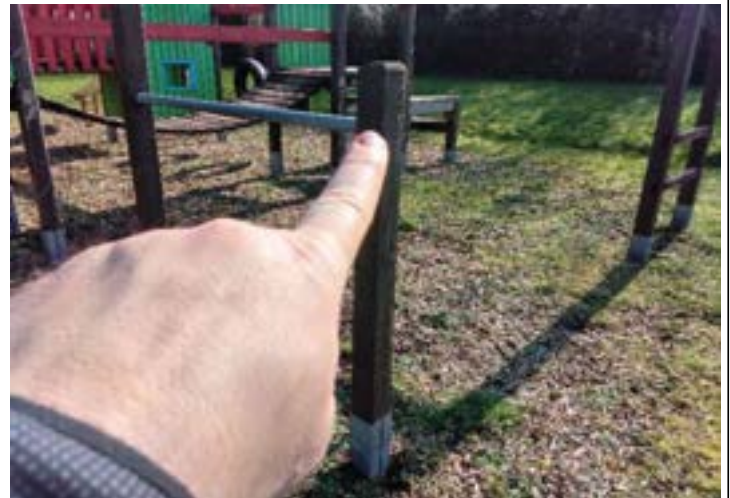
**Finding:** There are areas or parts of the posts x1 on the somersault bars that have rotted

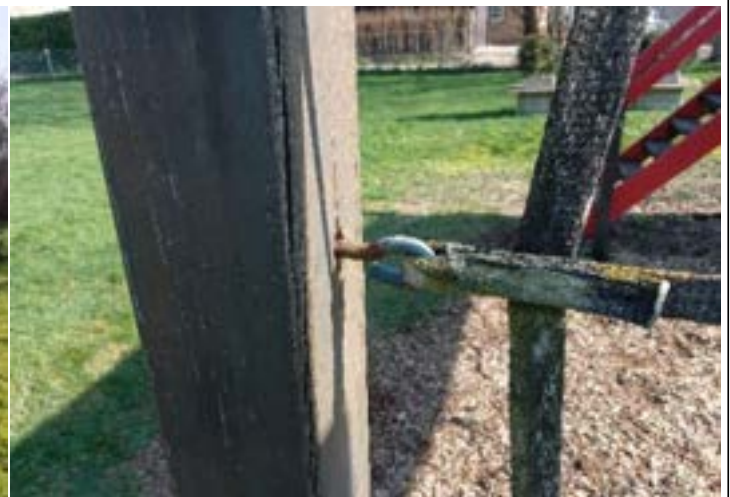
**Finding:** A number of net fixing(s) have worked loose

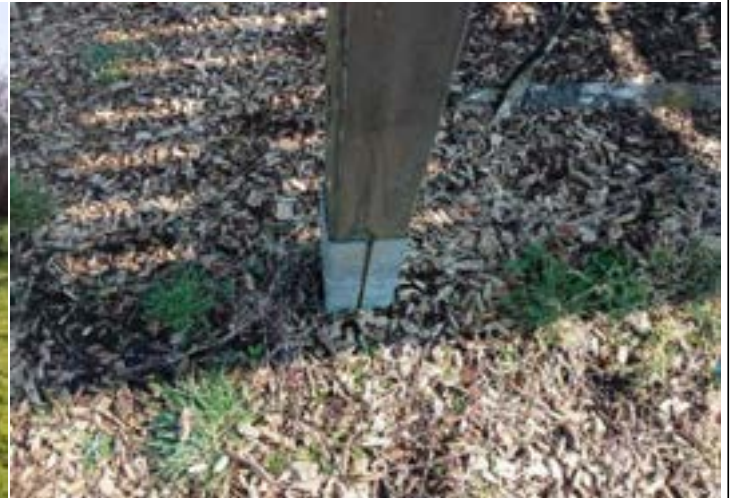
**Finding:** The item is slightly loose in its foundations

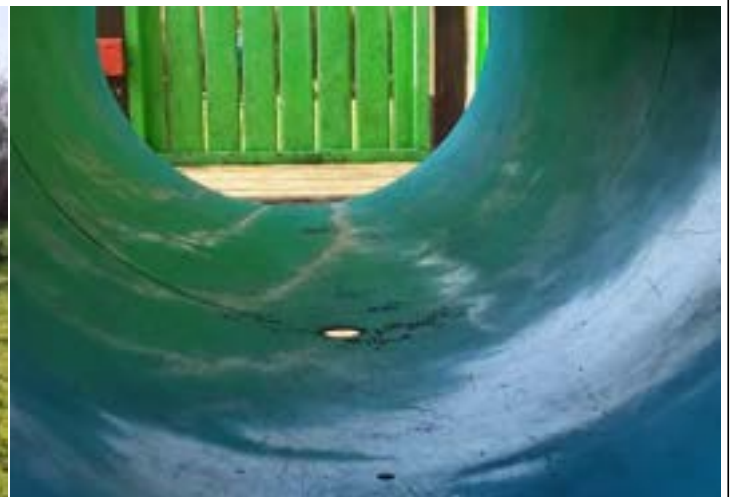
**Finding:** There is some evidence of fire damage to the tunnel

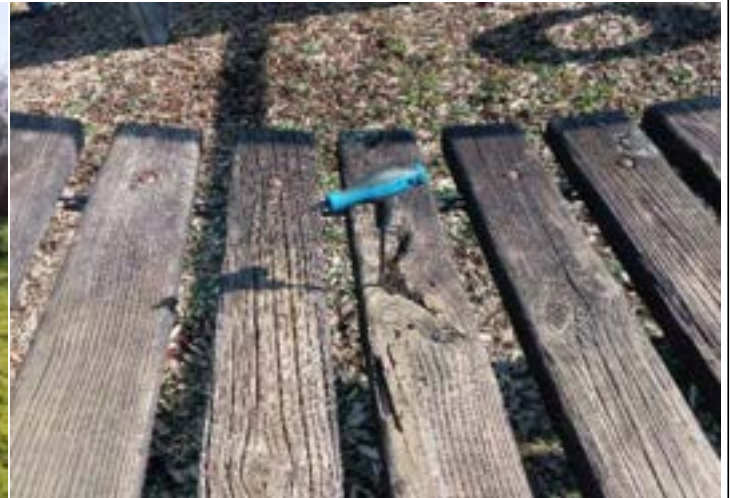
**Finding:** There is some evidence of rot in the suspension bridge

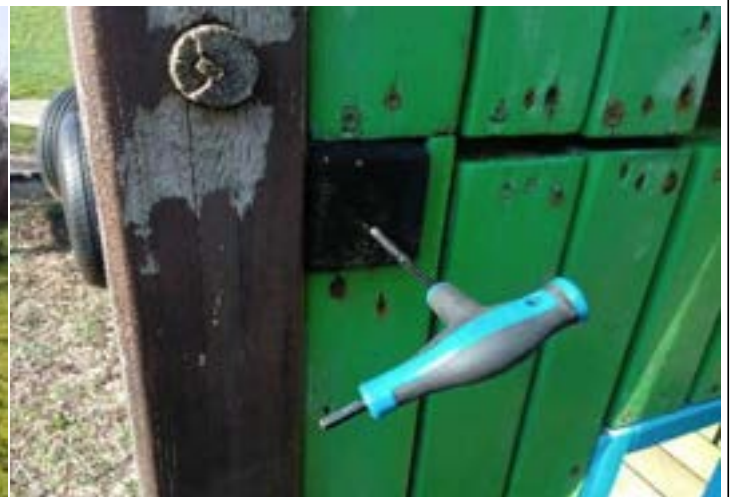
**Finding:** There is some evidence of rot in the timber

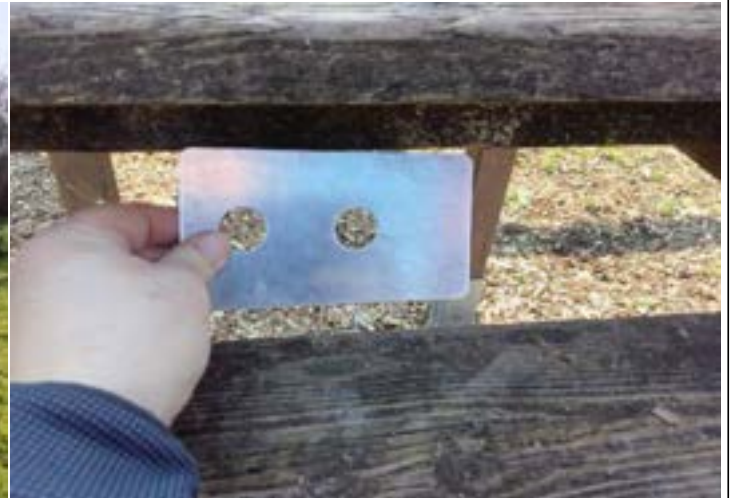
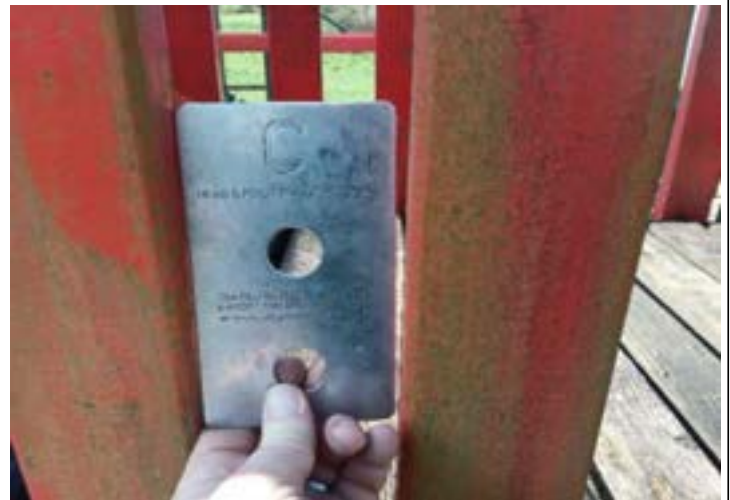
**Finding:** The item fails to meet the requirements of BS EN 1176 Part 1 4.2.7.2 head and neck entrapment in the barriers and/or steps

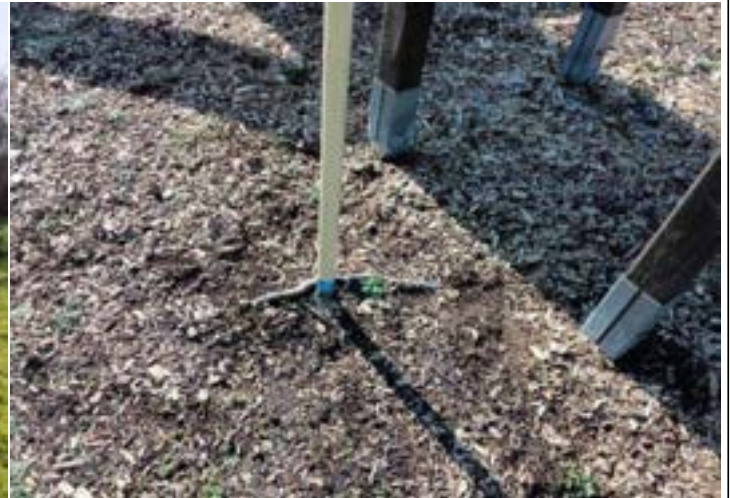
**Finding:** The tree roots / exposed foundations form a projecting obstacle / hard object within the falling space / impact area of the equipment, in contravention of the requirements of BS EN 1176 Part 1

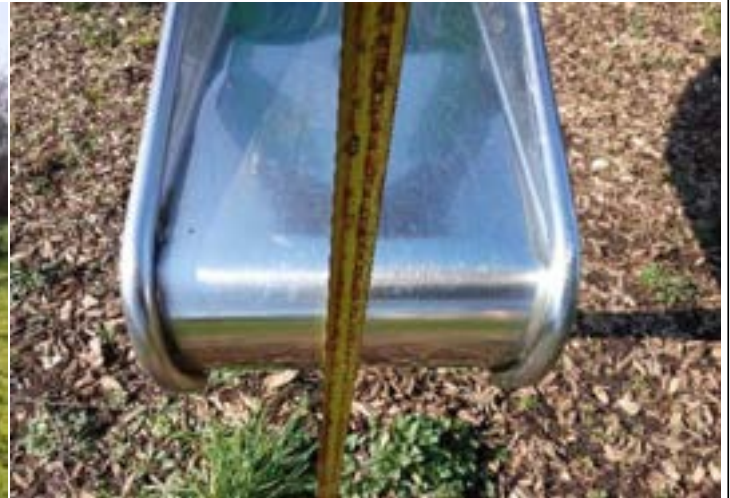
**Finding:** The height of the slide runout is in excess of 350mm and does not meet the requirements of BS EN 1176: Part 3
