## Annual Inspection

Iwerne Minster Parish Council

Iwerne Minster Play Area

Watery Lane, Blandford Forum, DT11 8NB

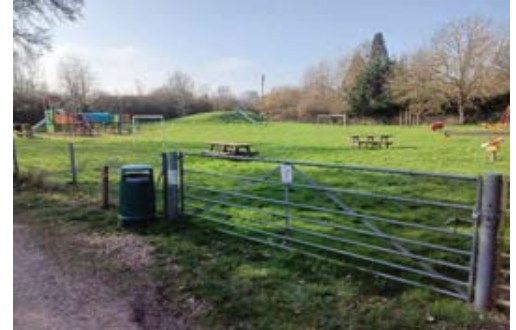
**Item:** Site General  
**Manufacturer:** Owner/Operator  
**Surface Type:** N/A  
**Item Quantity:** 1  
**Equipment Compliance:** N/A  
**Surface Area Compliance:** N/A

There are a number of molehills within the area and these may present unforeseen hazards for users - Remove moles by appropriate means, reinstate surfaces to level and maintain the area

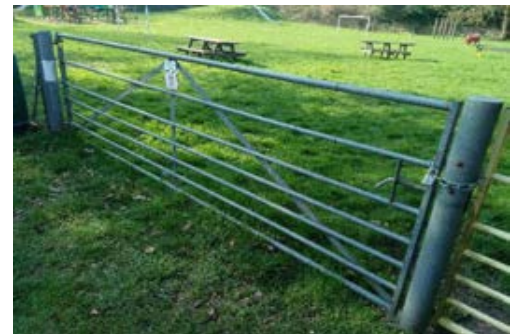
**Item:** Gate - Maintenance  
**Manufacturer:** Not Identified  
**Surface Type:** Grass  
**Item Quantity:** 1  
**Equipment Compliance:** N/A  
**Surface Area Compliance:** N/A

The maintenance gate was correctly padlocked at the time of inspection, however this means that the inspector was unable to fully assess the gate - Ensure that there are 12mm gaps throughout the full range of motion on gate/s and between leaves where relevant

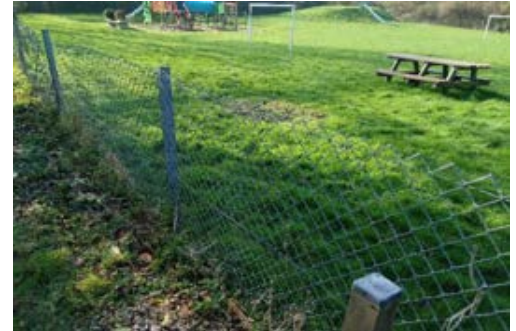
**Item:** Fence - Chainlink  
**Manufacturer:** Not Identified  
**Surface Type:** Grass  
**Item Quantity:** 1  
**Equipment Compliance:** N/A  
**Surface Area Compliance:** N/A

The fence is severely damaged in places - Repair or replace all affected sections

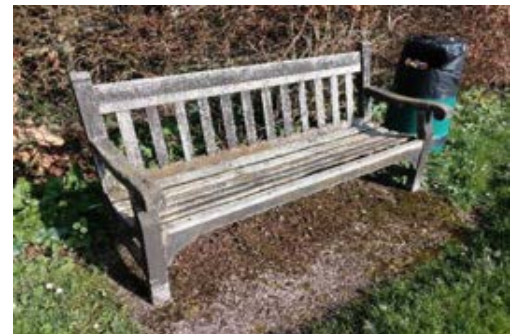
**Item:** Bench  
**Manufacturer:** Not Identified  
**Surface Type:** Concrete  
**Item Quantity:** 3  
**Equipment Compliance:** N/A  
**Surface Area Compliance:** N/A

There is algae, silt or moss growth on the surface resulting in slippery conditions - Clean and treat appropriately

There are areas or parts of the timber on the structure that have rotted - Replace all affected timbers

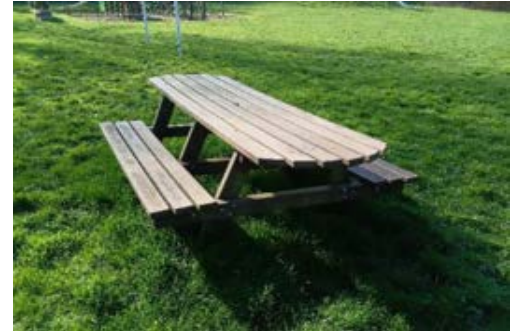
**Item:** Picnic Table  
**Manufacturer:** Not Identified  
**Surface Type:** Grass  
**Item Quantity:** 2  
**Equipment Compliance:** N/A  
**Surface Area Compliance:** N/A

The table/s is/are not secured to the ground and there is some potential for the item/s to be moved within falling spaces of equipment - Secure to the ground

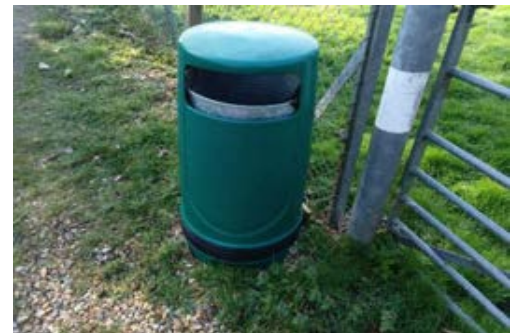
**Item:** Litter Bin  
**Manufacturer:** Glasdon  
**Surface Type:** Grass  
**Item Quantity:** 2  
**Equipment Compliance:** N/A  
**Surface Area Compliance:** N/A

The lid or door of the litter bin is not secured - Ensure the lid or door is kept locked

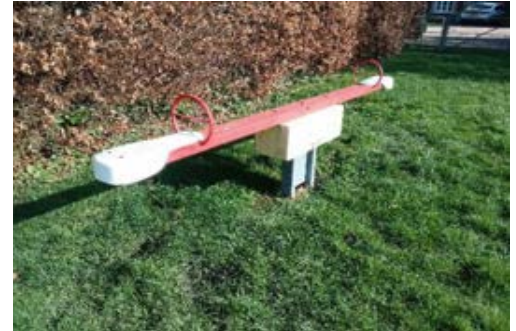
**Item:** See Saw  
**Manufacturer:** GL Jones  
**Surface Type:** Grass  
**Item Quantity:** 1  
**Equipment Compliance:** Yes  
**Surface Area Compliance:** Yes  
**Life Expectancy:** 5 -10 Years  
**Total Findings:** 3

There are projecting bolt thread(s) present - Remove excess thread length and deburr or provide cap

The seat has minor damage or wear - Monitor for any further deterioration and replace as required

The signage is damaged - Repacel

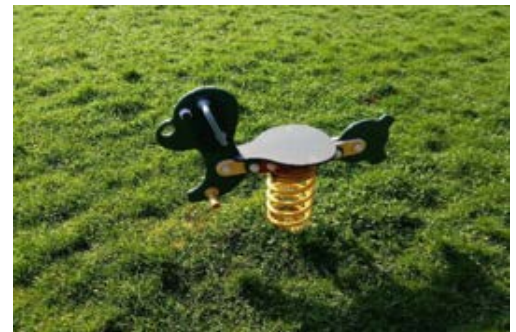
**Item:** Spring Dog  
**Manufacturer:** Fahr Industries  
**Surface Type:** Grass  
**Item Quantity:** 1  
**Equipment Compliance:** No  
**Surface Area Compliance:** Yes  
**Life Expectancy:** 5 -10 Years  
**Total Findings:** 3

The end of handgrips and/or footrests have a cross section of less than 15cm<sup>2</sup> and fail to meet the requirements of BS EN 1176 Part 6 - Monitor - No action given the risk assessment

The end caps are missing on the Handgrips/Footrests - Replace missing end caps

The paintwork on the spring has been damaged or worn exposing the metal underneath which is rusting - Treat any rusting components and repaint

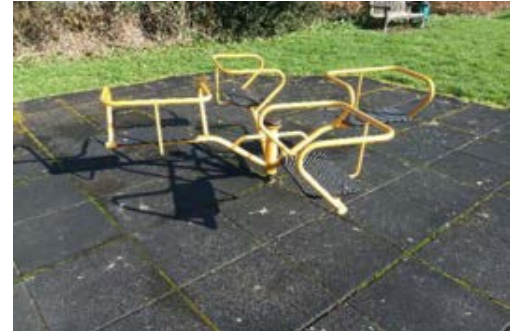
**Item:** Rotating Chairs  
**Manufacturer:** Wicksteed Playgrounds  
**Surface Type:** Rubber Tiles  
**Item Quantity:** 1  
**Equipment Compliance:** No  
**Surface Area Compliance:** Yes  
**Life Expectancy:** 5 -10 Years  
**Total Findings:** 5

There is algae, silt or moss growth on the surface resulting in slippery conditions - Clean and treat appropriately

The bearing is showing signs of wear - Monitor for any further deterioration and replace as required

There are gaps opening in between the tiles - Monitor for any further deterioration and repair as required

Parts of the steel structure protrude beyond the protected elements of the seat and fail to meet the requirements of BS EN 1176 Part 5 - Monitor - No action given the risk assessment

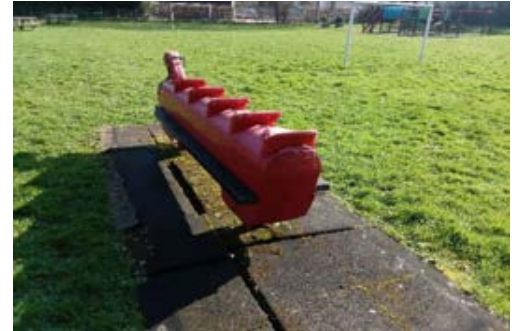
**Item:** Rocking Horse  
**Manufacturer:** Wicksteed Playgrounds  
**Surface Type:** Rubber Tiles  
**Item Quantity:** 1  
**Equipment Compliance:** No  
**Surface Area Compliance:** Yes  
**Life Expectancy:** 3 - 5 Years  
**Total Findings:** 7

There are significant gaps (over 30mm) between the tiles; these are large enough for a small foot to enter - Repair surfacing

The paintwork on this item has been damaged or worn exposing the metal underneath which is rusting / corroding - Treat affected areas and repaint

A number of fixing(s) have worked loose - Secure all loose fixings

There is algae, silt or moss growth on the surface resulting in slippery conditions - Clean and treat appropriately

There is no gaiter protection for accessible moving parts (possible shear trap) as recommended in BS EN 1176 Part 1; 4.2.6 Moving Parts - Monitor - No action given the risk assessment

The fixings have corroded excessively - Replace all corroded fixings

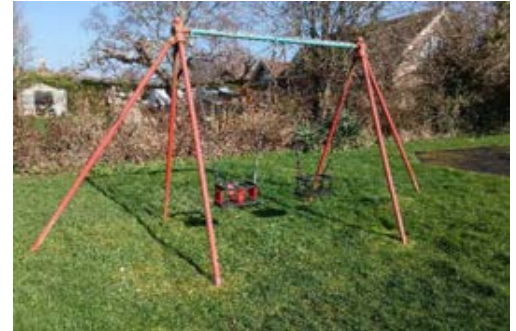
**Item:** 1 Bay 2 Seat (Cradle)  
**Manufacturer:** Wicksteed Playgrounds  
**Surface Type:** Grass  
**Item Quantity:** 1  
**Equipment Compliance:** No  
**Surface Area Compliance:** Yes  
**Life Expectancy:** 5 -10 Years  
**Total Findings:** 10

The seat/s is / are too close to the frame as defined in BS EN 1176 Part 2 - Monitor - No action given the risk assessment

The chain openings are in excess of the 8.6mm as recommended by BS EN 1176 - Monitor - No action given the risk assessment

The bush / bushes is / are showing signs of wear - Monitor for any further deterioration and replace as required

There is some wear to the connecting links - Monitor for any further deterioration and replace when 40% worn

The paintwork on this item has been damaged or worn exposing the metal underneath which is rusting / corroding - Treat affected areas and repaint

The seats are too close to each other as defined in BS EN 1176 Part 2; this is a low risk failure and no remedial action is required - Monitor - No action given the risk assessment

The seat has minor damage or wear - Monitor for any further deterioration and replace as required

There is some notable evidence of chain wear - Monitor for any further deterioration and replace when 40% worn

Crucifix or T connectors should have at least two complete chain links through the connector to meet with the manufacturers recommendations - Rectify installation to ensure at least two complete links are through the connectors

Bird deterrents have been fitted to the crossbar - Replace with upturned cable ties

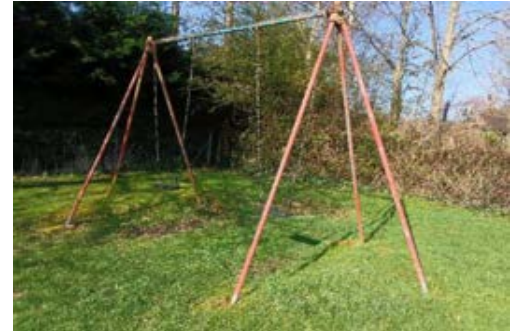
**Item:** 1 Bay 2 Seat (Flat)  
**Manufacturer:** Wicksteed Playgrounds  
**Surface Type:** Grass  
**Item Quantity:** 1  
**Equipment Compliance:** No  
**Surface Area Compliance:** Yes  
**Life Expectancy:** 3 - 5 Years  
**Total Findings:** 13

The depth of the loose fill surfacing is lower than the recommended depth specified in BS EN 1176; the free height of fall of the equipment is less than 2.0m and a minimum of 300mm depth should be provided (including an extra 100mm to allow for compaction and displacement as per BS EN 1176 Part 1 - Table 4) - Top up loose fill surfacing to recommended levels

The surface has eroded and the foundations are exposed - Reinstate surrounding surfaces to cover the foundations

The paintwork on this item has been damaged or worn exposing the metal underneath which is rusting / corroding - Treat affected areas and repaint

Bird deterrents have been fitted to the crossbar - Replace with upturned cable ties

The seat has minor damage or wear - Monitor for any further deterioration and replace as required

There is some notable evidence of chain wear - Monitor for any further deterioration and replace when 40% worn

The bush / bushes is / are showing signs of wear - Monitor for any further deterioration and replace as required

There is some wear to the shackles. - Monitor for any further deterioration and replace when 40% worn

The framework has been damaged - Monitor for any further deterioration and replace as required

The chain openings are in excess of the 8.6mm as recommended by BS EN 1176 - Monitor - No action given the risk assessment

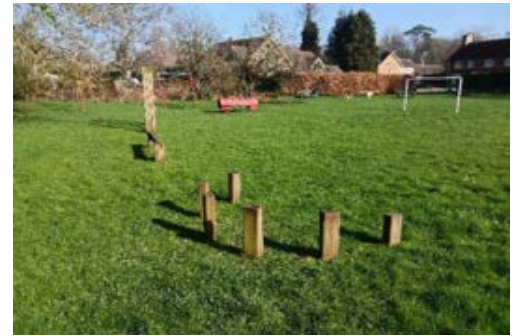
**Item:** Activity Trail  
**Manufacturer:** Home Front Ltd  
**Surface Type:** Grass  
**Item Quantity:** 1  
**Equipment Compliance:** Yes  
**Surface Area Compliance:** Yes  
**Life Expectancy:** 1 - 3 Years  
**Total Findings:** 5

There are areas or parts of the stepping posts that have rotted - Replace all affected timbers

There is some evidence of rot in the timber - Monitor for any further deterioration and replace as required

There are areas or parts of the stilts that have rotted - Replace all affected timbers

The timber stain is in poor condition - Prepare all affected parts and re-stain with an appropriate preservative

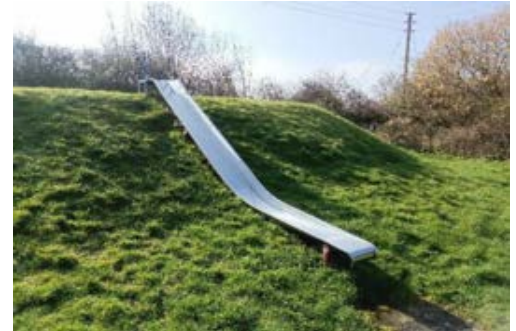
**Item:** Embankment Slide  
**Manufacturer:** Not Identified  
**Surface Type:** Grass  
**Item Quantity:** 1  
**Equipment Compliance:** Yes  
**Surface Area Compliance:** Yes  
**Life Expectancy:** 5 -10 Years  
**Total Findings:** 6

The height of the slide runout is in excess of 350mm and does not meet the requirements of BS EN 1176: Part 3 - Monitor - No action given the risk assessment

The paintwork on this item has been damaged or worn exposing the metal underneath which is rusting / corroding - Treat affected areas and repaint

There is some evidence of fire damage to the item (potentially from a weld repair) - Monitor for any further deterioration and repair as required

The surface has eroded and the foundations are exposed - Reinstall surrounding surfaces to cover the foundations

There is algae, silt or moss growth on the surface resulting in slippery conditions - Clean and treat appropriately

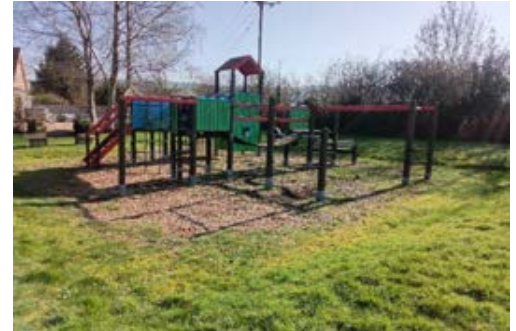
**Item:** Multi Play (Junior)  
**Manufacturer:** Not Identified  
**Surface Type:** Woodchip  
**Item Quantity:** 1  
**Equipment Compliance:** No  
**Surface Area Compliance:** Yes  
**Life Expectancy:** 1 - 3 Years  
**Total Findings:** 28

The depth of the loose fill surfacing is lower than the recommended depth specified in BS EN 1176; the free height of fall of the equipment is less than 2.0m and a minimum of 300mm depth should be provided (including an extra 100mm to allow for compaction and displacement as per BS EN 1176 Part 1 - Table 4) - Top up loose fill surfacing to recommended levels

There are areas or parts of the posts x2 on the monkey bars that have rotted - Replace all affected timbers

The fixings have corroded excessively - Replace all corroded fixings

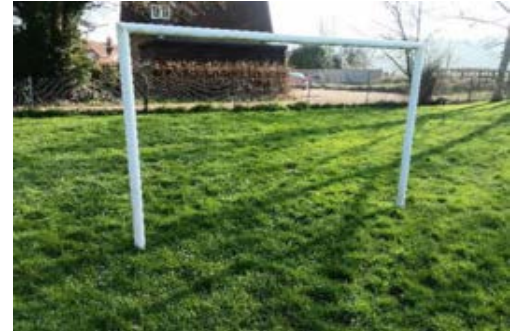
NB: We have undertaken a maintenance inspection only of the football goal(s); full load testing falls outside the scope of our inspection. - Implement load testing as required

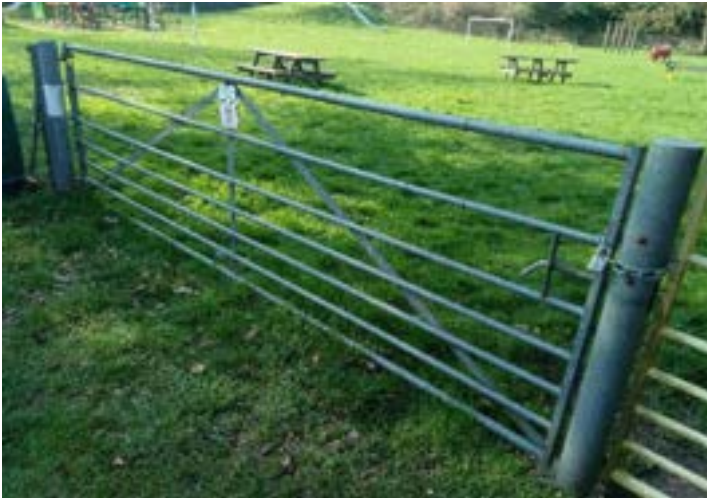
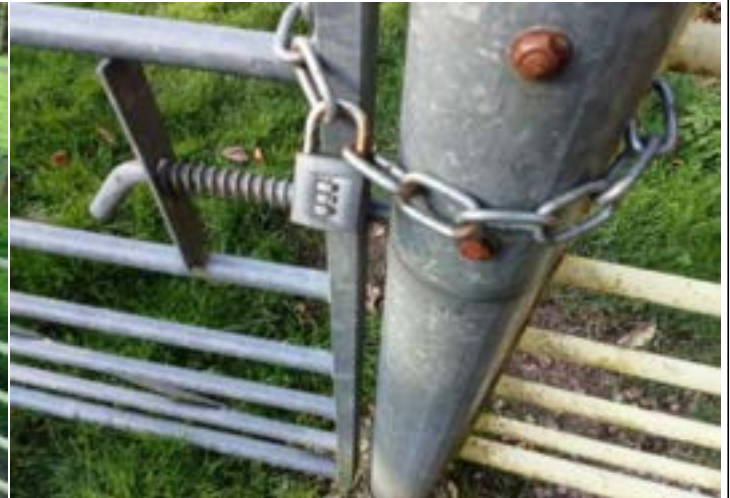
**Item:** Gates - Gate - Maintenance  
**Manufacturer:** Not Identified

**Finding:** The maintenance gate was correctly padlocked at the time of inspection, however this means that the inspector was unable to fully assess the gate

**Action:** Ensure that there are 12mm gaps throughout the full range of motion on gate/s and between leaves where relevant

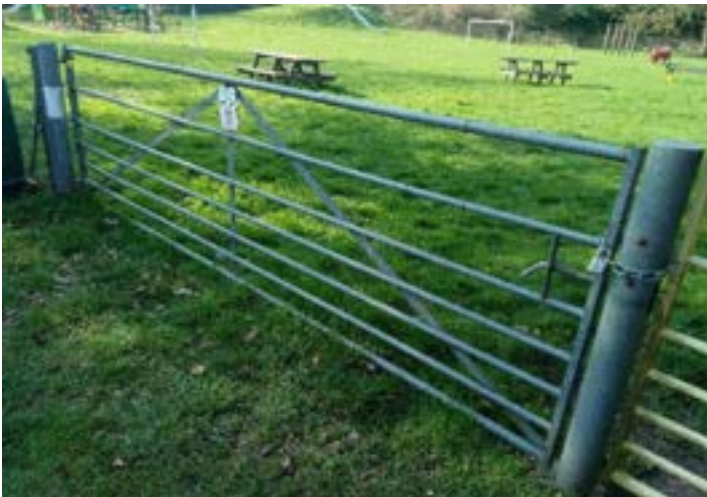
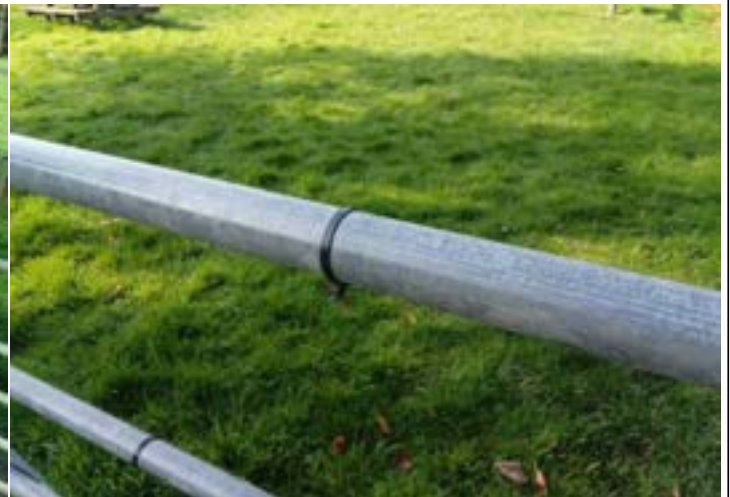
**Item:** Gates - Gate - Maintenance  
**Manufacturer:** Not Identified

**Finding:** Cable ties are present and there are sharp projecting ends

**Action:** Remove

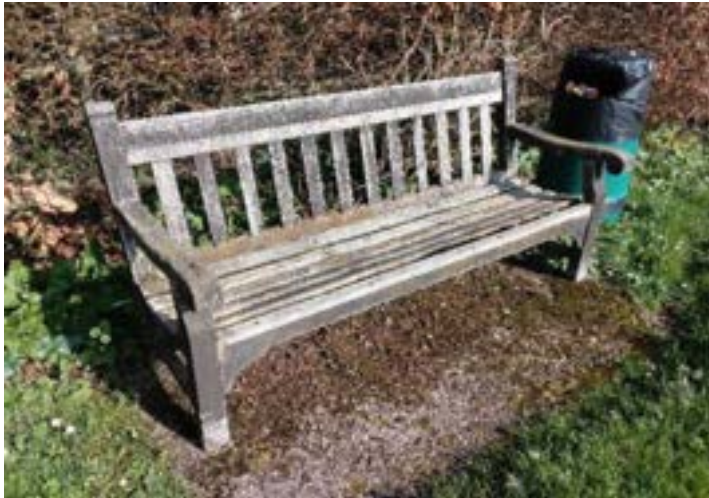
**Item:** Ancillary Items - Bench  
**Manufacturer:** Not Identified

**Finding:** There are areas or parts of the timber on the structure that have rotted

**Action:** Replace all affected timbers

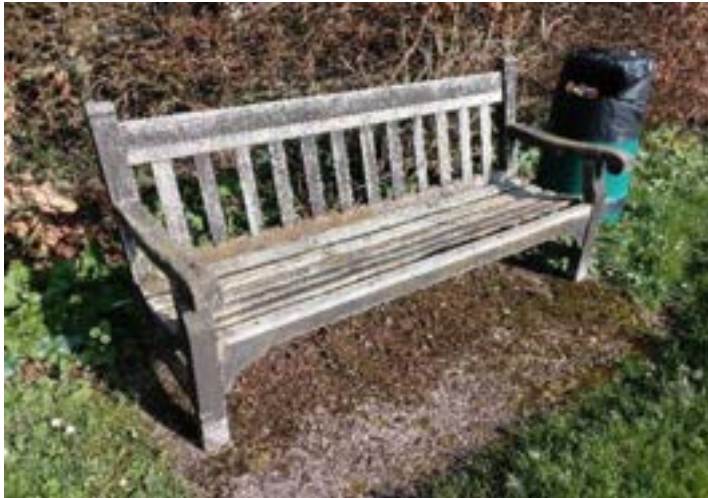
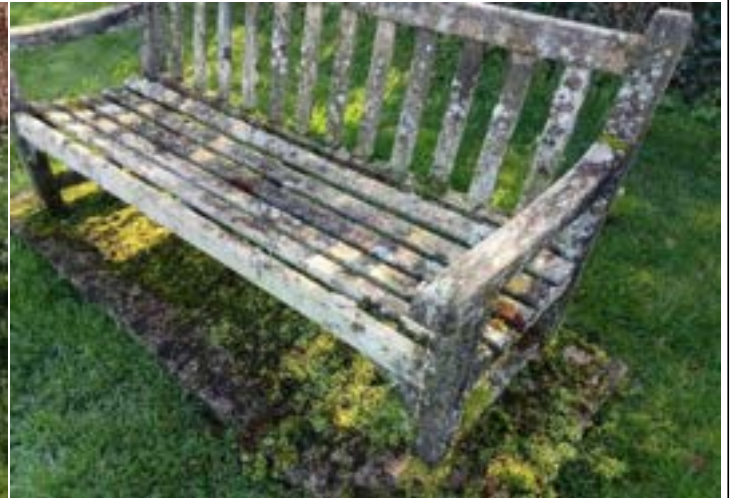
**Item:** Ancillary Items - Bench  
**Manufacturer:** Not Identified

**Finding:** There is algae or moss on the surface of the equipment

**Action:** Clean and treat appropriately

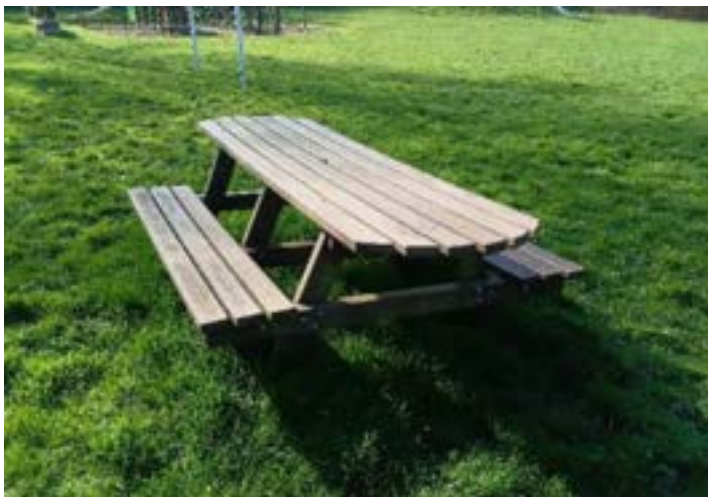
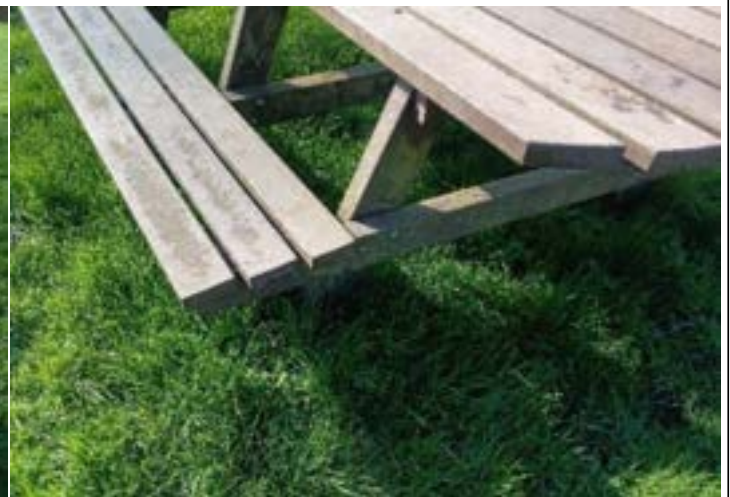
**Item:** Ancillary Items - Picnic Table  
**Manufacturer:** Not Identified

**Finding:** The table/s is/are not secured to the ground and there is some potential for the item/s to be moved within falling spaces of equipment

**Action:** Secure to the ground

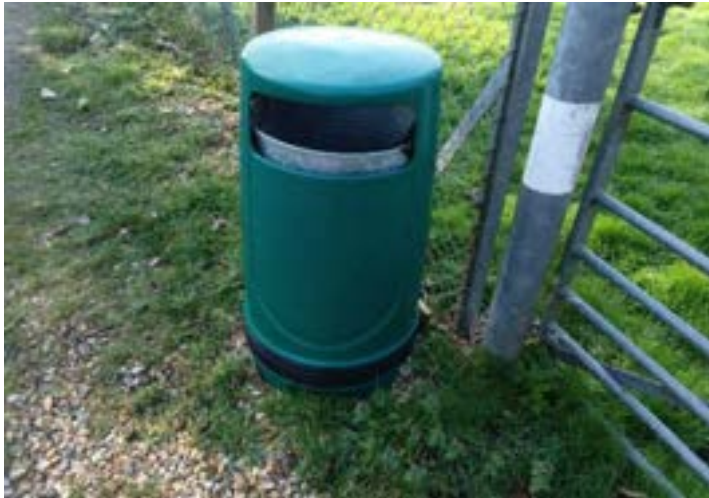
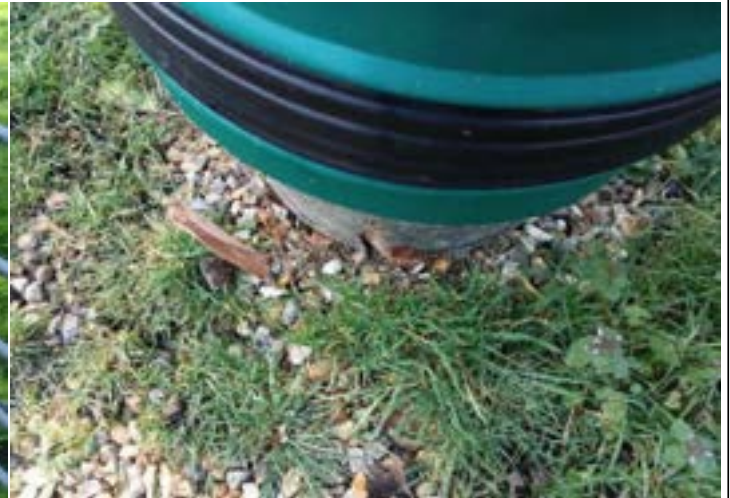
**Item:** Ancillary Items - Litter Bin  
**Manufacturer:** Glasdon

**Finding:** The lid or door of the litter bin is not secured

**Action:** Ensure the lid or door is kept locked

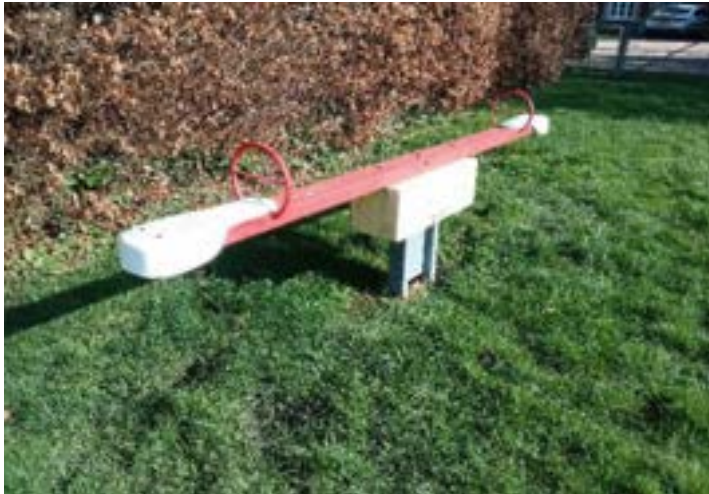
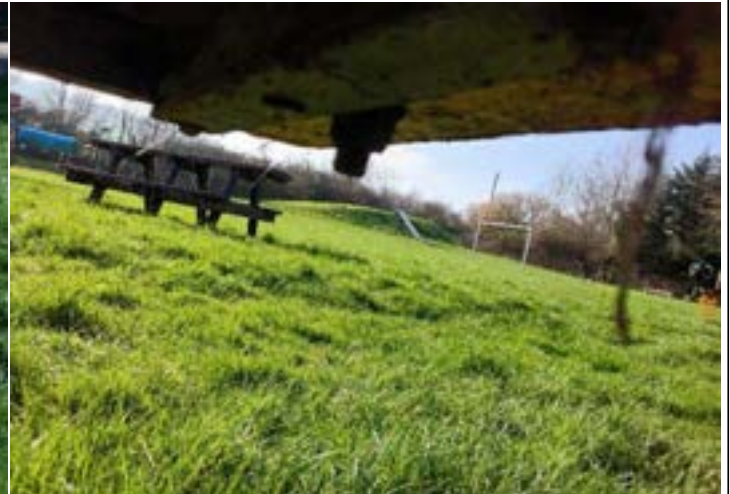
**Item:** Rocking Equipment - See Saw  
**Manufacturer:** GL Jones

**Finding:** There are projecting bolt thread(s) present

**Action:** Remove excess thread length and deburr or provide cap

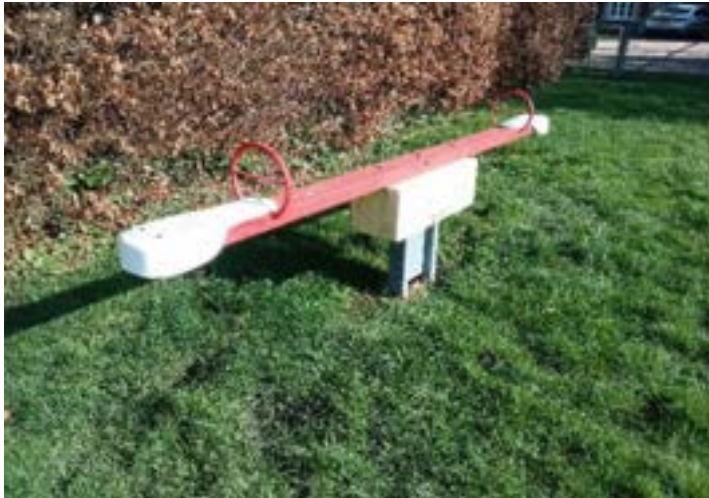
**Item:** Rocking Equipment - See Saw  
**Manufacturer:** GL Jones

**Finding:** The seat has minor damage or wear

**Action:** Monitor for any further deterioration and replace as required

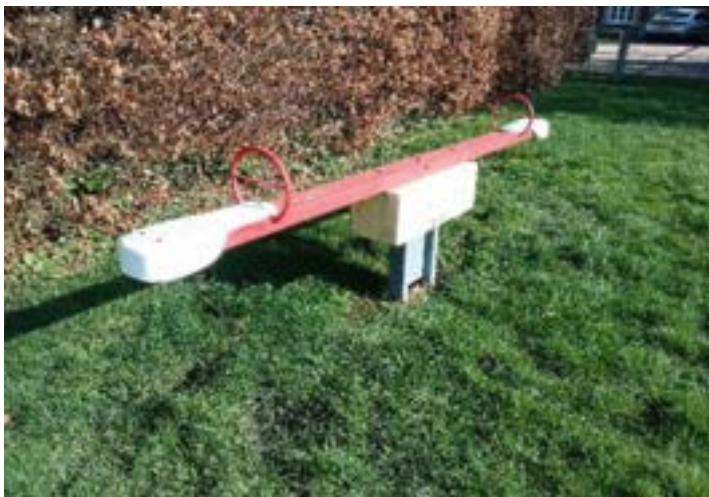
**Item:** Rocking Equipment - See Saw  
**Manufacturer:** GL Jones

**Finding:** The signage is damaged

**Action:** Repacel

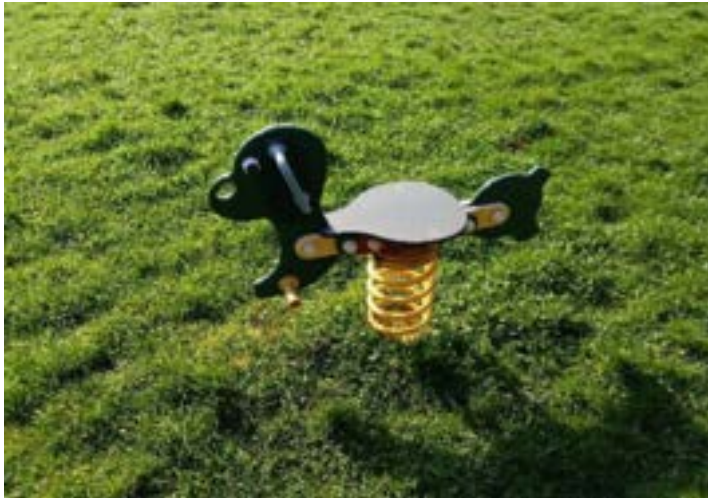
**Item:** Rocking Equipment - Spring Dog  
**Manufacturer:** Fahr Industries

**Finding:** The end of handgrips and/or footrests have a cross section of less than 15cm² and fail to meet the requirements of BS EN 1176 Part 6  
**Action:** Monitor - No action given the risk assessment

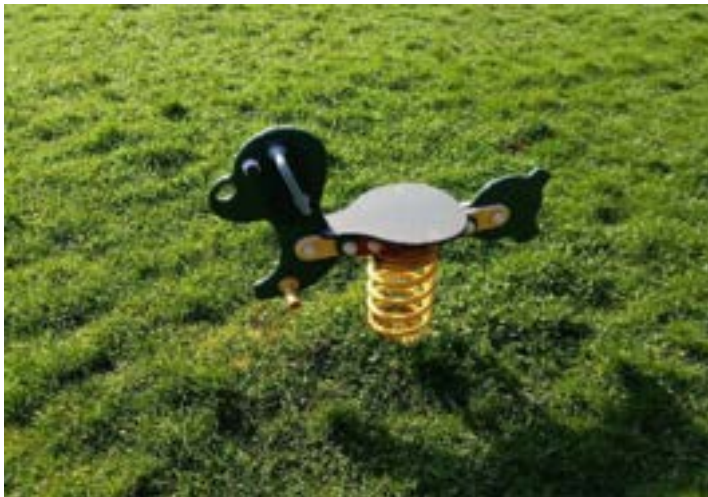
**Item:** Rocking Equipment - Spring Dog  
**Manufacturer:** Fahr Industries

**Finding:** The end caps are missing on the Handgrips/Footrests

**Action:** Replace missing end caps

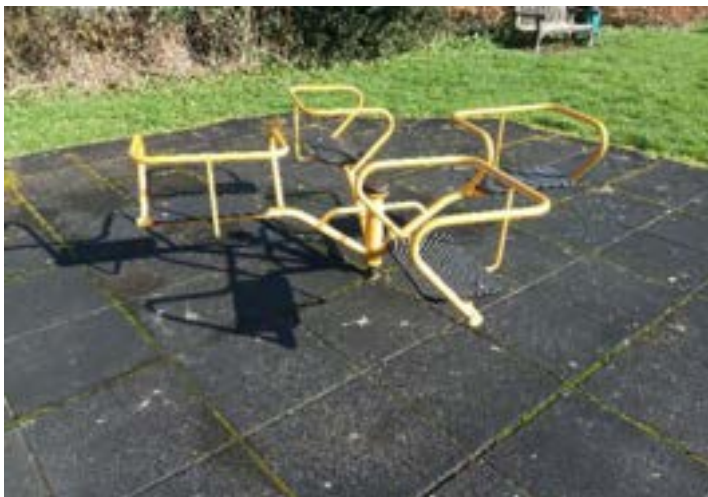
**Item:** Rotor Play - Rotating Chairs  
**Manufacturer:** Wicksteed Playgrounds

**Finding:** There is algae, silt or moss growth on the surface resulting in slippery conditions  
**Action:** Clean and treat appropriately

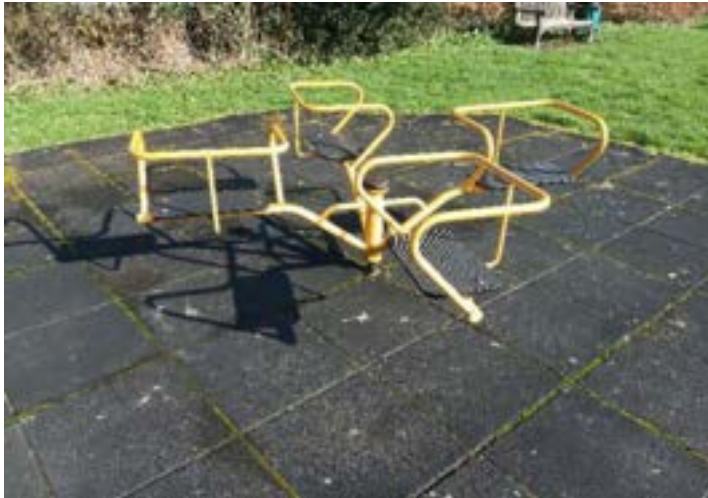
**Item:** Rotor Play - Rotating Chairs  
**Manufacturer:** Wicksteed Playgrounds

**Finding:** There are gaps opening in between the tiles

**Action:** Monitor for any further deterioration and repair as required

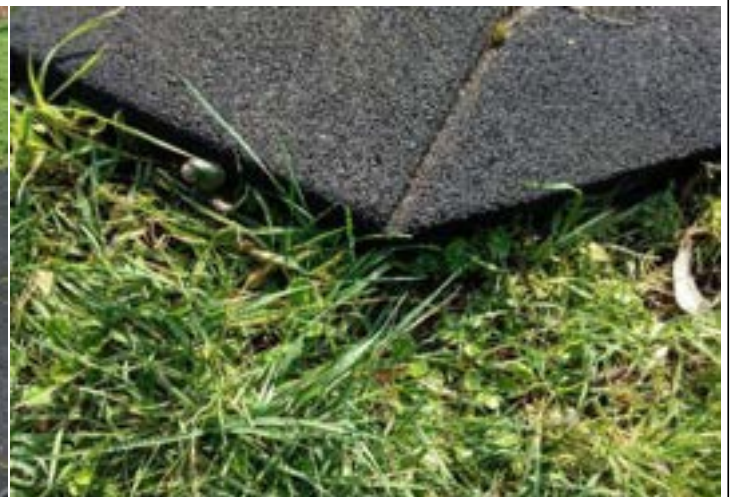
**Finding:** The tiles can easily be lifted or are lifting along the edges of the area

**Action:** Lift and re-glue tiles to secure

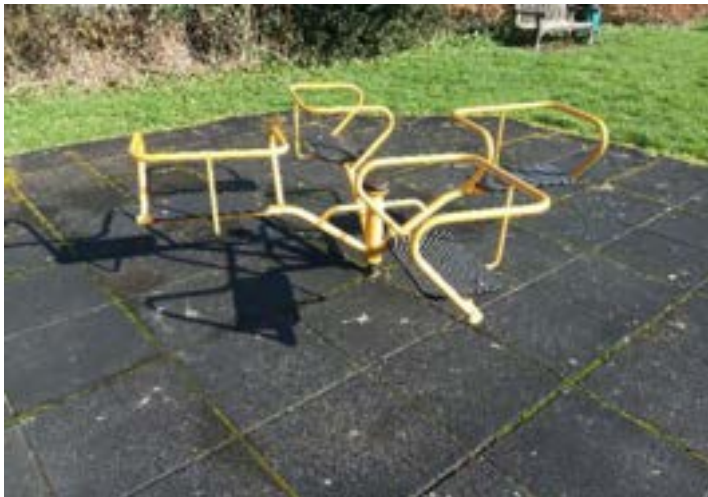
**Finding:** The bearing is showing signs of wear

**Action:** Monitor for any further deterioration and replace as required

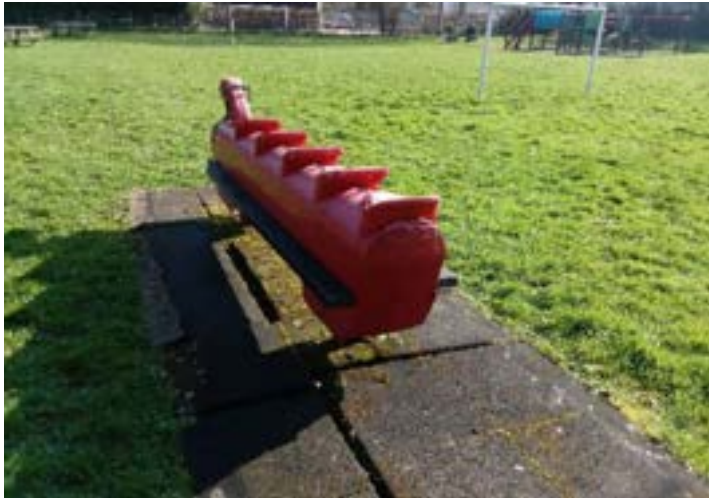
**Finding:** There are significant gaps (over 30mm) between the tiles; these are large enough for a small foot to enter

**Action:** Repair surfacing

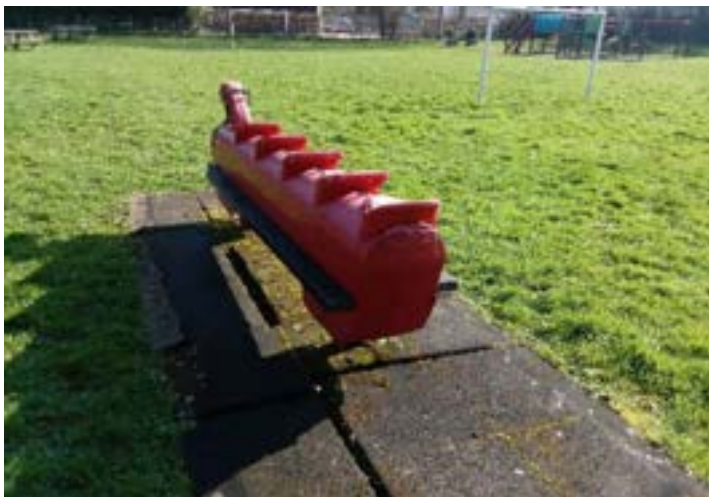
**Finding:** There is algae, silt or moss growth on the surface resulting in slippery conditions

**Action:** Clean and treat appropriately

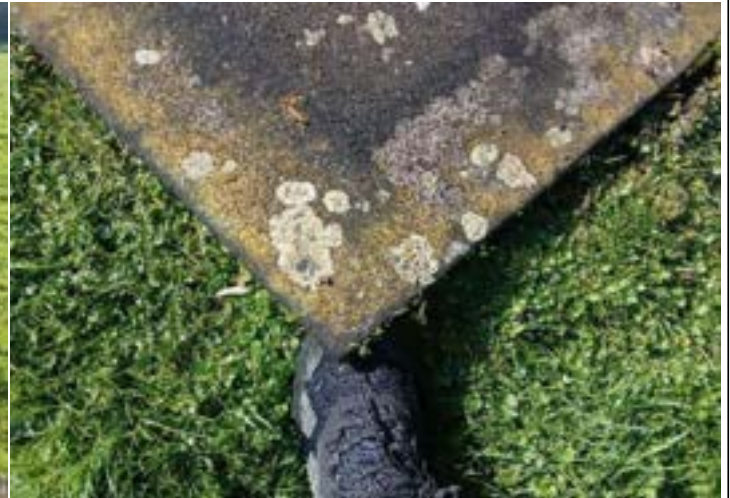
**Finding:** The tiles can easily be lifted or are lifting along the edges of the area  
**Action:** Lift and re-glue tiles to secure

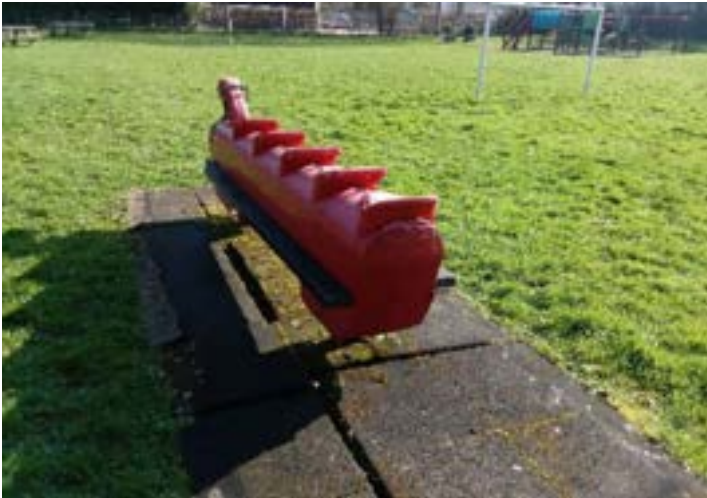
**Finding:** The fixings have corroded excessively

**Action:** Replace all corroded fixings

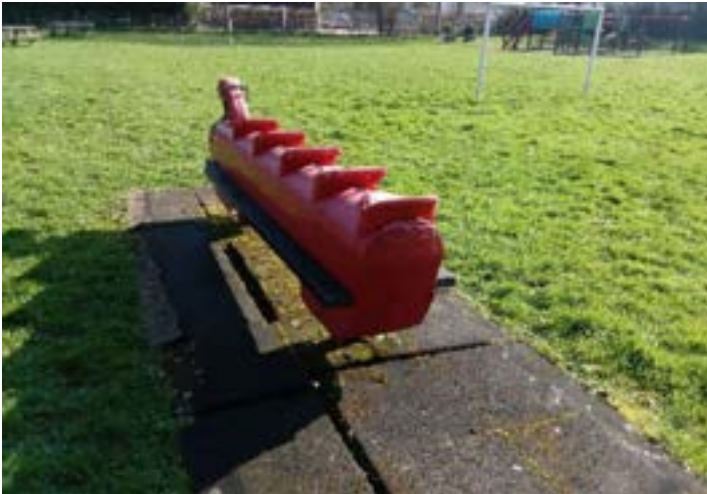
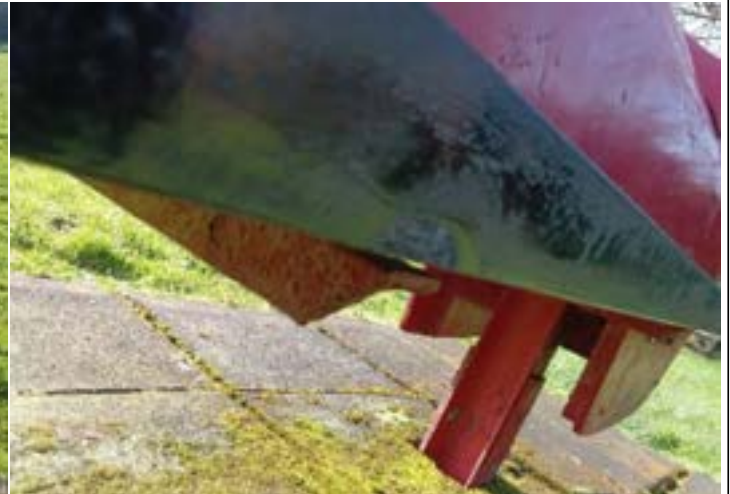
**Finding:** A number of fixing(s) have worked loose

**Action:** Secure all loose fixings

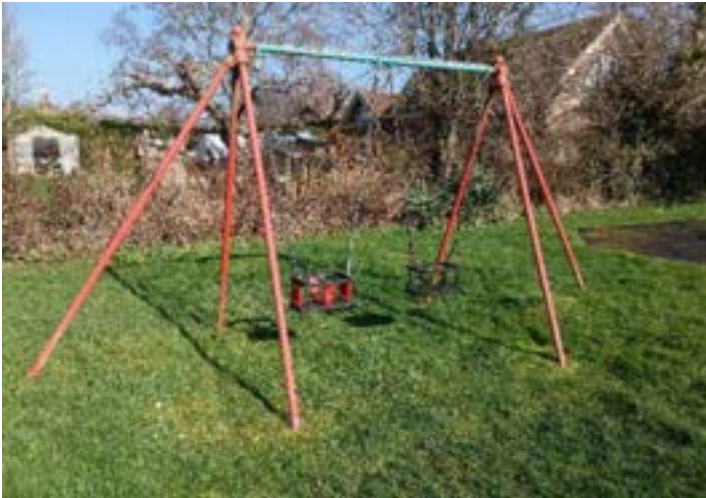
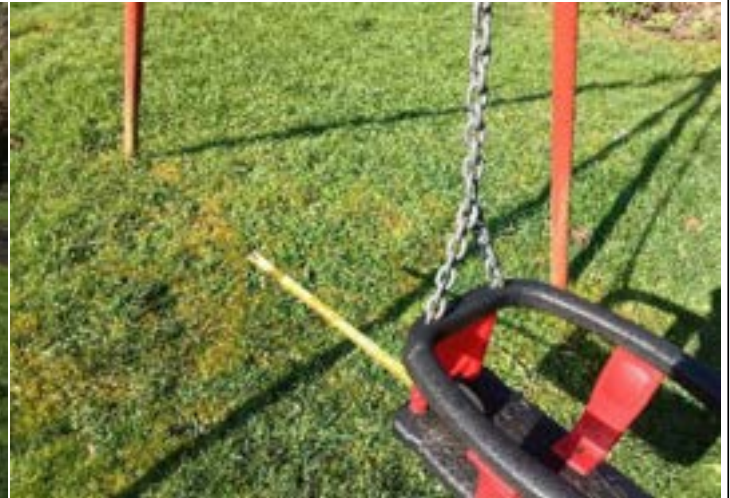
**Finding:** The seat/s is / are too close to the frame as defined in BS EN 1176 Part 2

**Action:** Monitor - No action given the risk assessment

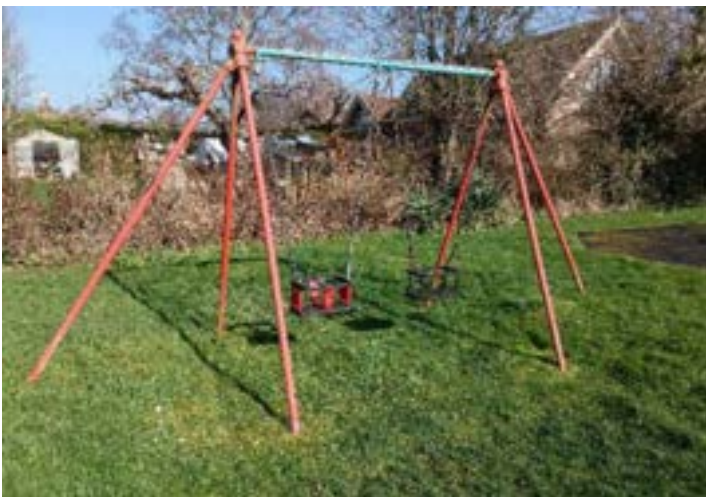
**Finding:** The seats are too close to each other as defined in BS EN 1176 Part 2; this is a low risk failure and no remedial action is required

**Action:** Monitor - No action given the risk assessment

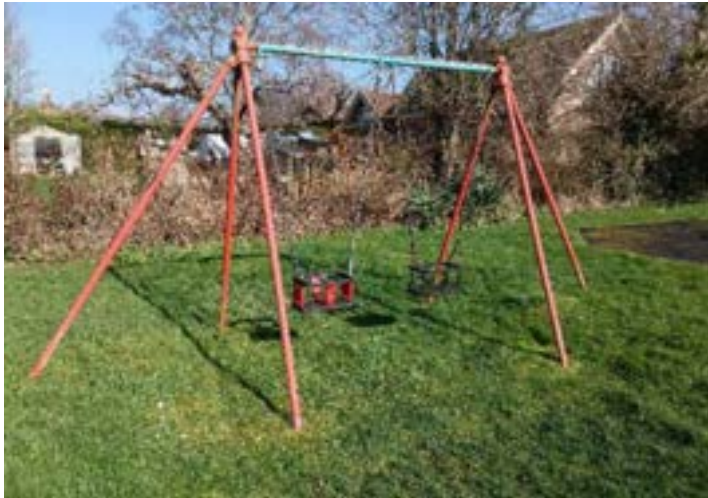
**Finding:** The chain openings are in excess of the 8.6mm as recommended by BS EN 1176  
**Action:** Monitor - No action given the risk assessment

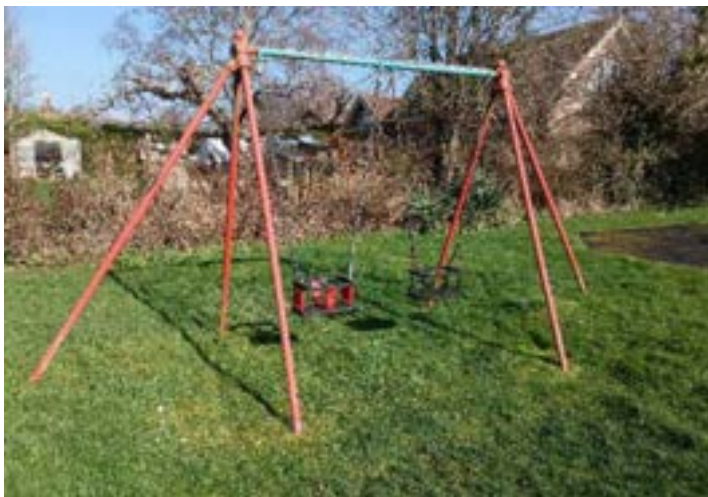
**Finding:** The seat has minor damage or wear  
**Action:** Monitor for any further deterioration and replace as required

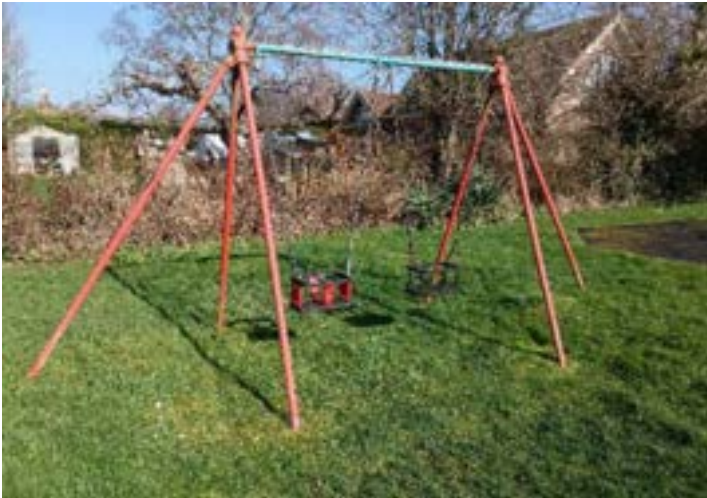
**Finding:** The bush / bushes is / are showing signs of wear

**Action:** Monitor for any further deterioration and replace as required

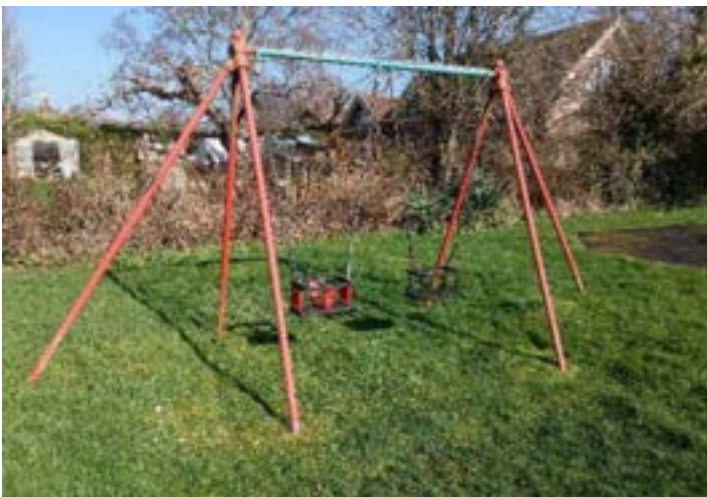
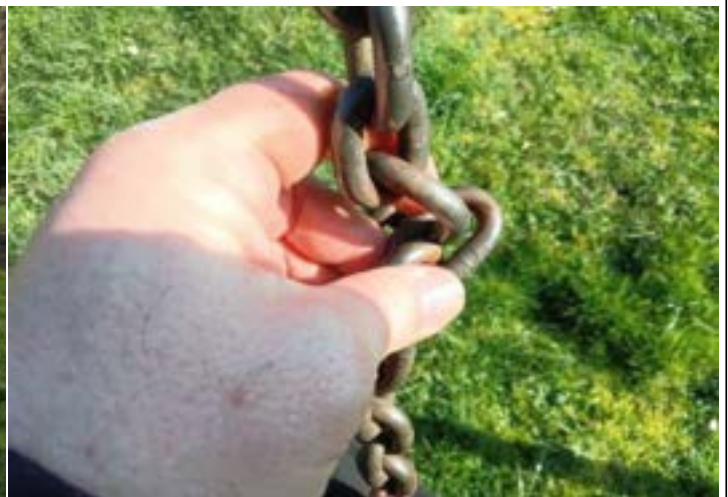
**Finding:** There is some notable evidence of chain wear

**Action:** Monitor for any further deterioration and replace when 40% worn

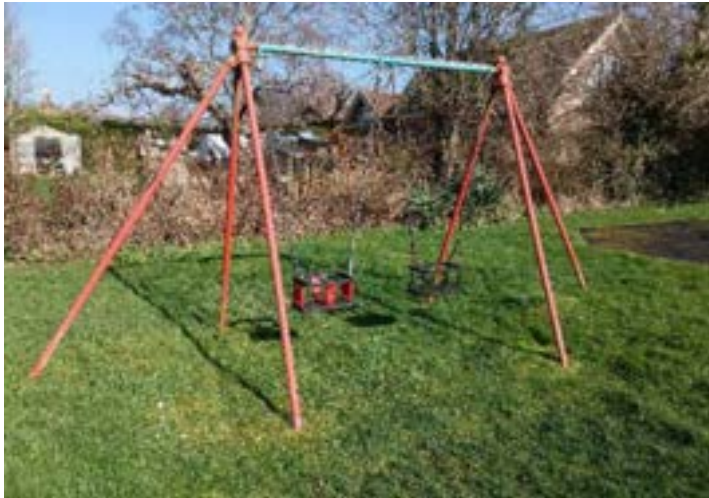
**Finding:** The paintwork on this item has been damaged or worn exposing the metal underneath which is rusting / corroding

**Action:** Treat affected areas and repaint

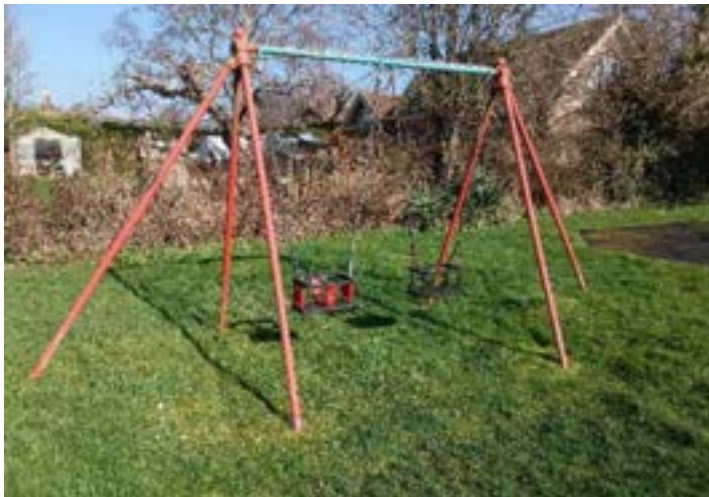
**Finding:** Bird deterrents have been fitted to the crossbar

**Action:** Replace with upturned cable ties

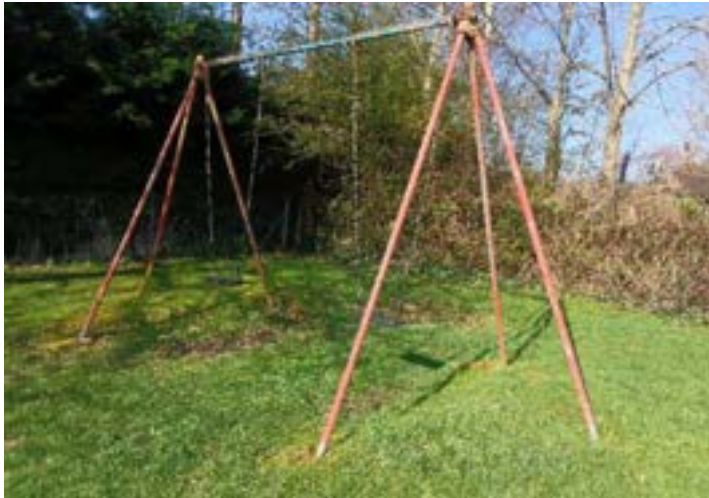
**Finding:** The depth of the loose fill surfacing is lower than the recommended depth specified in BS EN 1176; the free height of fall of the equipment is less than 2.0m and a minimum of 300mm depth should be provided (including an extra 100mm to allow for compaction and displacement as per BS EN 1176 Part 1 - Table 4)

**Action:** Top up loose fill surfacing to recommended levels

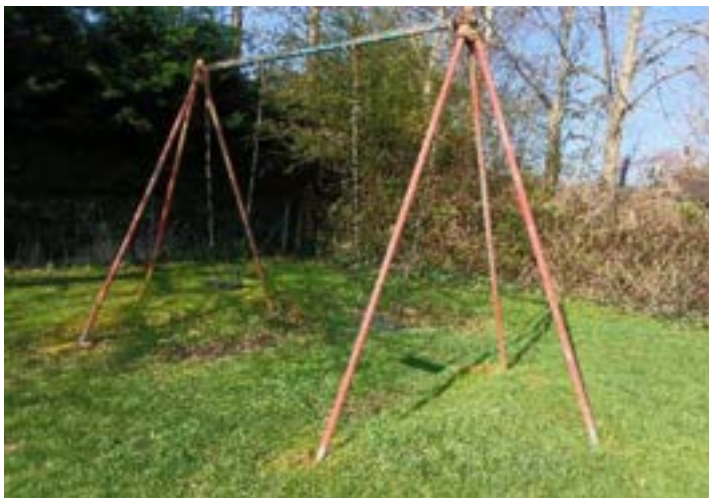
**Finding:** The surface has eroded and the foundations are exposed

**Action:** Reinstate surrounding surfaces to cover the foundations

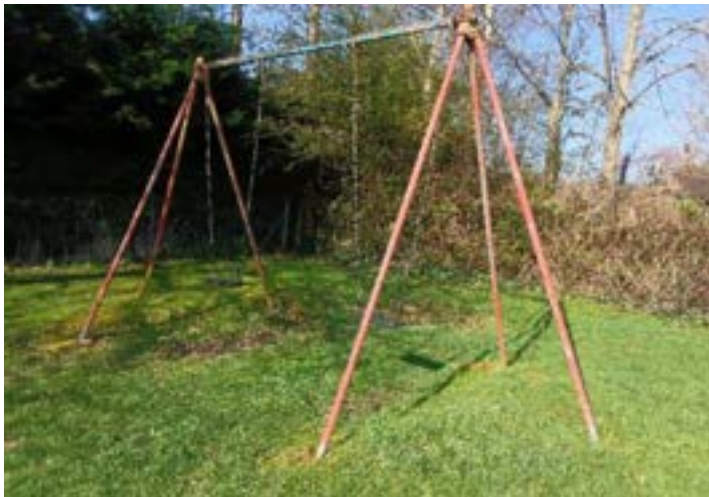
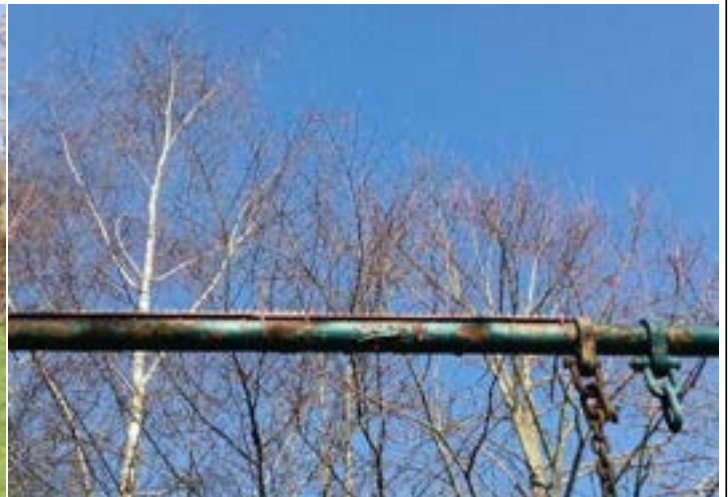
**Finding:** Bird deterrents have been fitted to the crossbar

**Action:** Replace with upturned cable ties

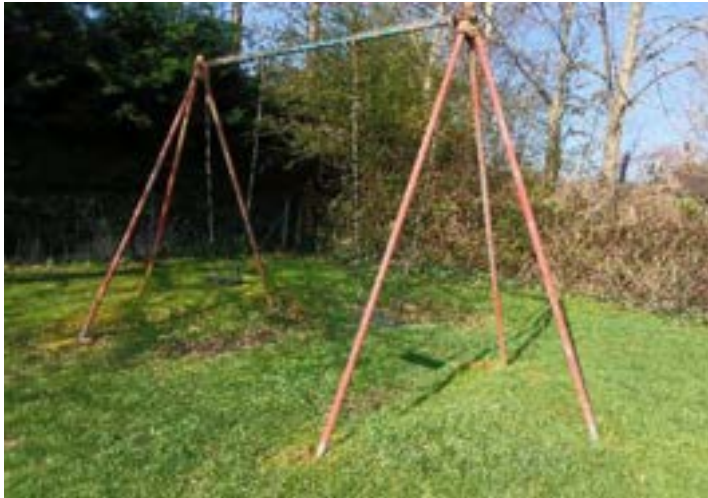
**Finding:** The seat has minor damage or wear

**Action:** Monitor for any further deterioration and replace as required

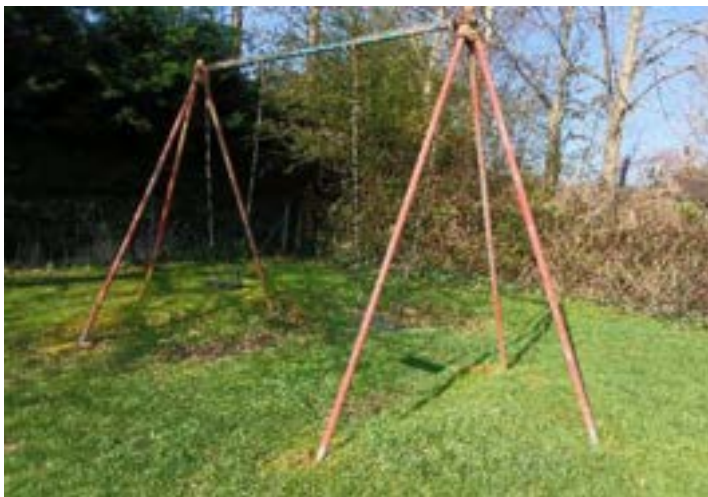
**Finding:** There is some notable evidence of chain wear

**Action:** Monitor for any further deterioration and replace when 40% worn
