## Annual Inspection

Iwerne Minster Parish Council

Iwerne Minster Play Area

Watery Lane, Blandford Forum, DT11 8NB

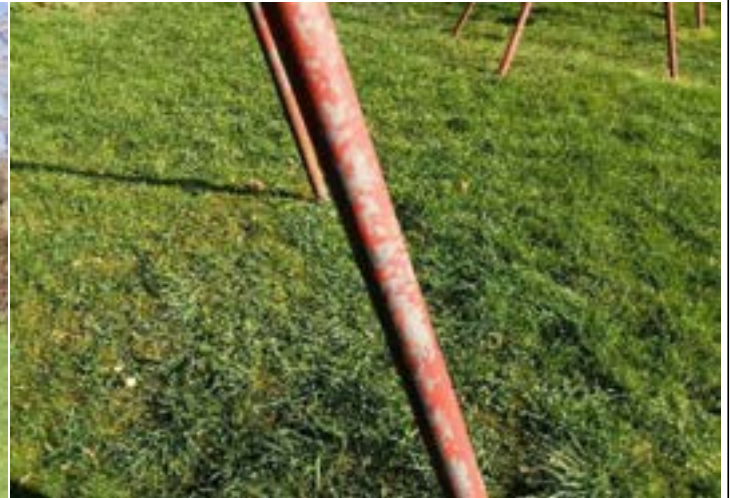
**Finding:** The paint is flaking off the metalwork

**Action:** Rub down and re-paint

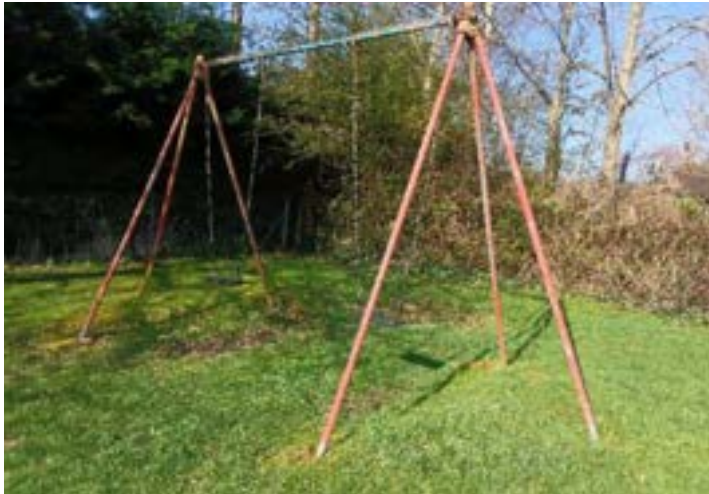
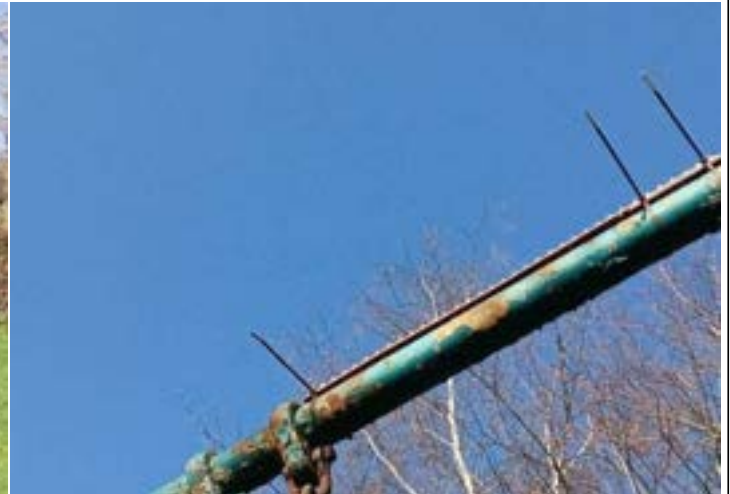
**Finding:** The bush / bushes is / are showing signs of wear

**Action:** Monitor for any further deterioration and replace as required

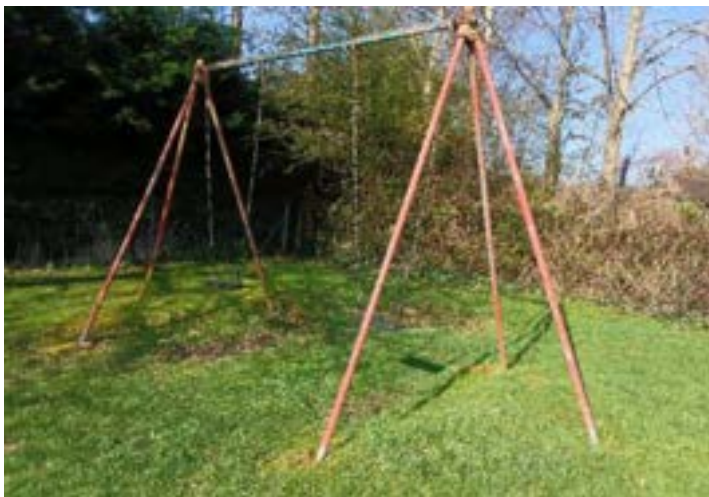
**Finding:** The framework has been damaged

**Action:** Monitor for any further deterioration and replace as required

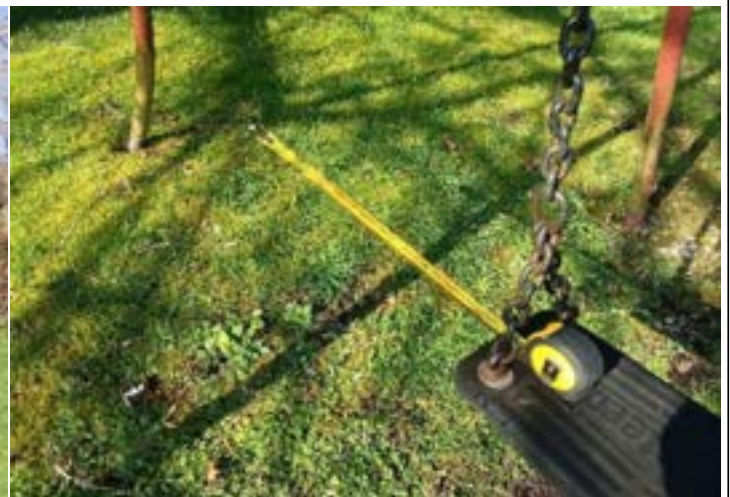
**Finding:** The seat/s is / are too close to the frame as defined in BS EN 1176 Part 2

**Action:** Monitor - No action given the risk assessment

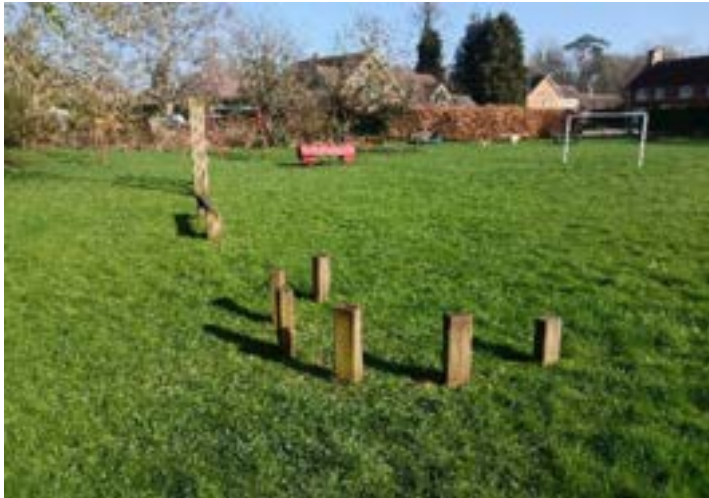
**Finding:** There are areas or parts of the stepping posts that have rotted  
**Action:** Replace all affected timbers

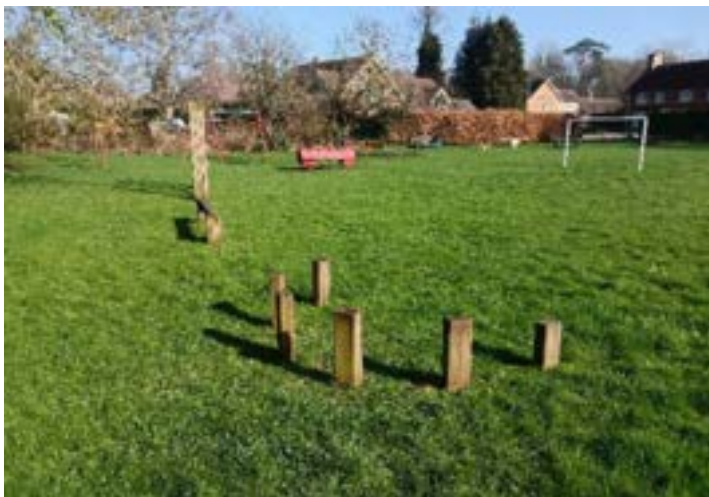
**Finding:** There is some evidence of rot in the timber

**Action:** Monitor for any further deterioration and replace as required

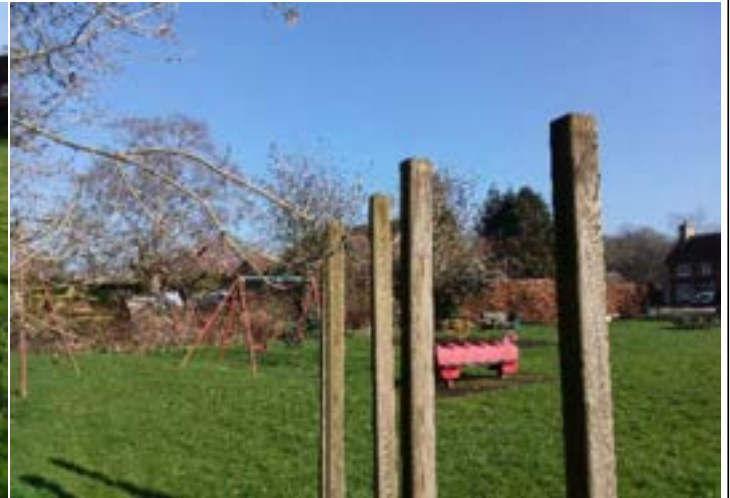
**Finding:** The tree canopy overhangs the equipment and is less than 2.0m away

**Action:** Lift tree canopy to ensure a minimum clearance of 2.0m from the equipment

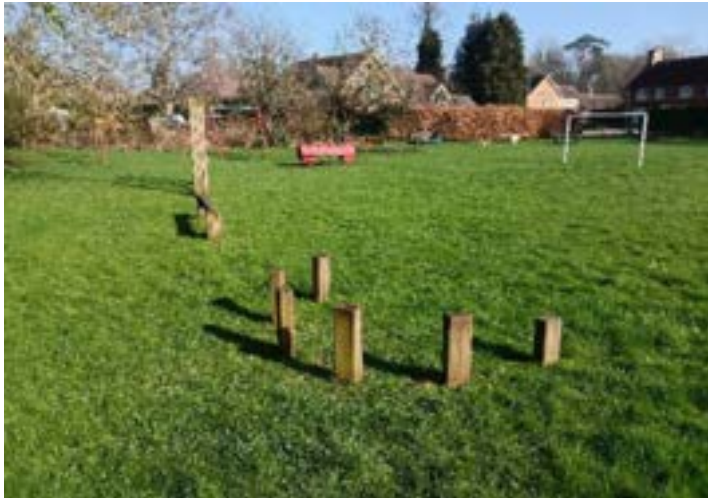
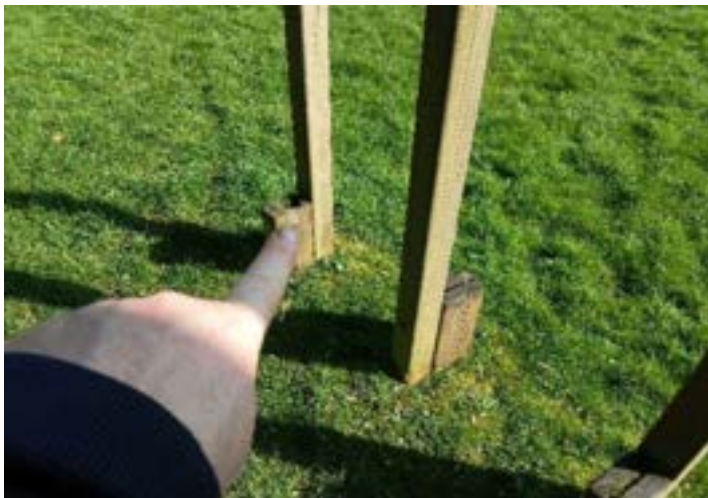
**Finding:** There are areas or parts of the stilts that have rotted

**Action:** Replace all affected timbers

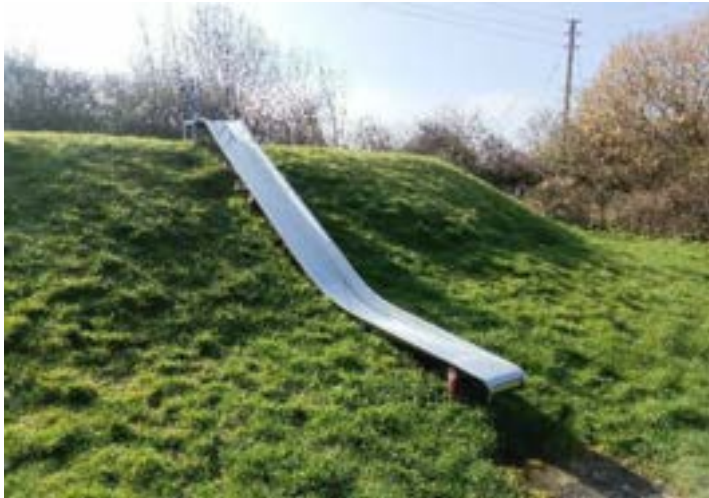
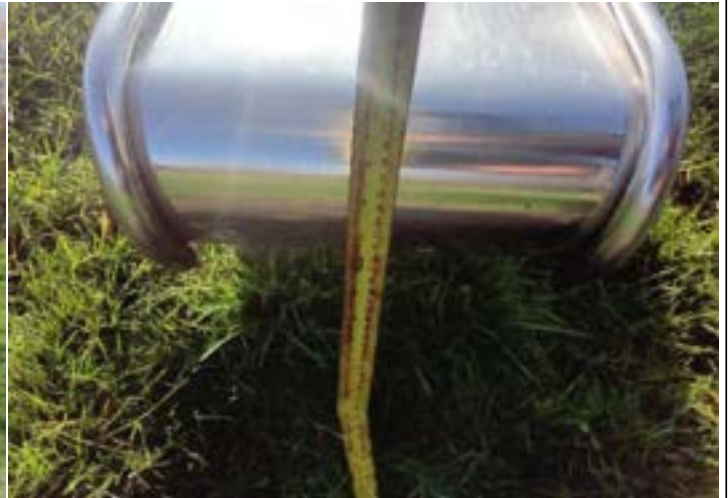
**Finding:** The height of the slide runout is in excess of 350mm and does not meet the requirements of BS EN 1176: Part 3

**Action:** Monitor - No action given the risk assessment

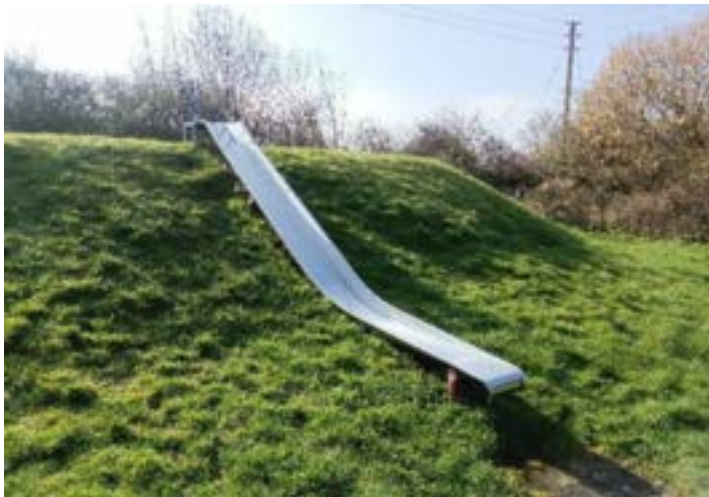
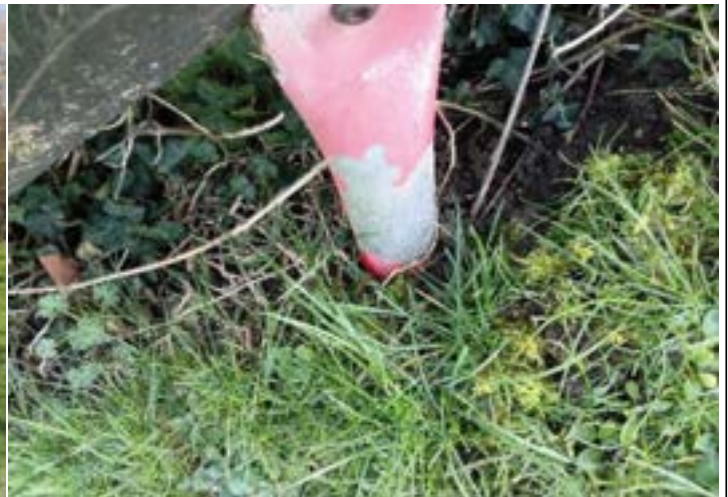
**Finding:** The paint is flaking off the metalwork

**Action:** Rub down and re-paint

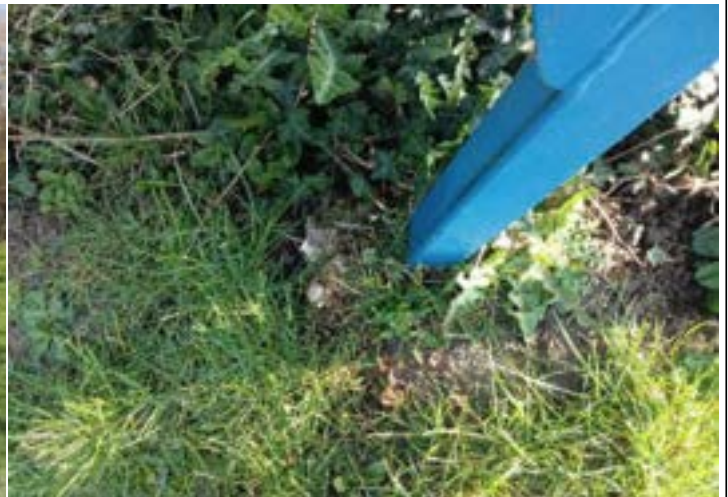
**Finding:** The surface has eroded and the foundations are exposed

**Action:** Reinststate surrounding surfaces to cover the foundations

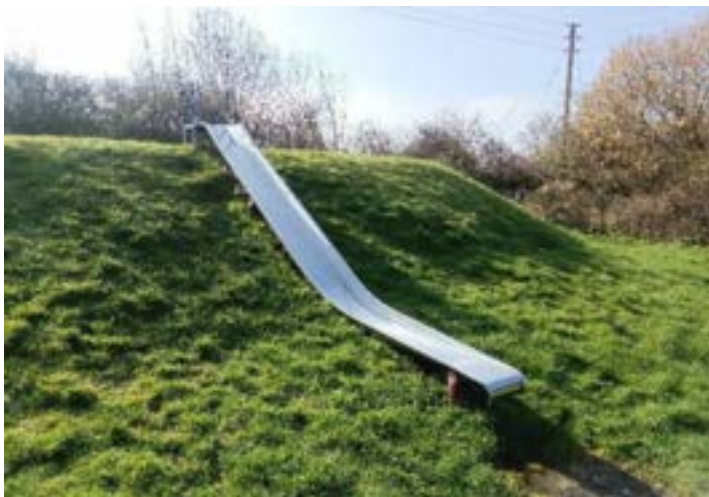
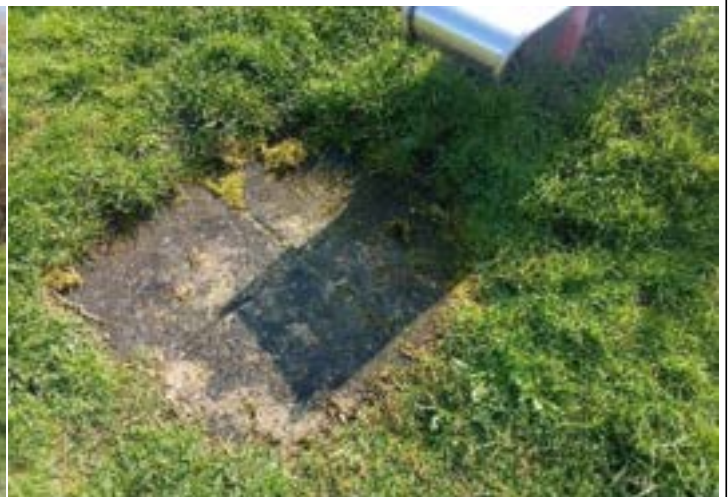
**Item:** Other - Embankment Slide  
**Manufacturer:** Not Identified

**Finding:** There is algae, silt or moss growth on the surface resulting in slippery conditions **Action:** Clean and treat appropriately

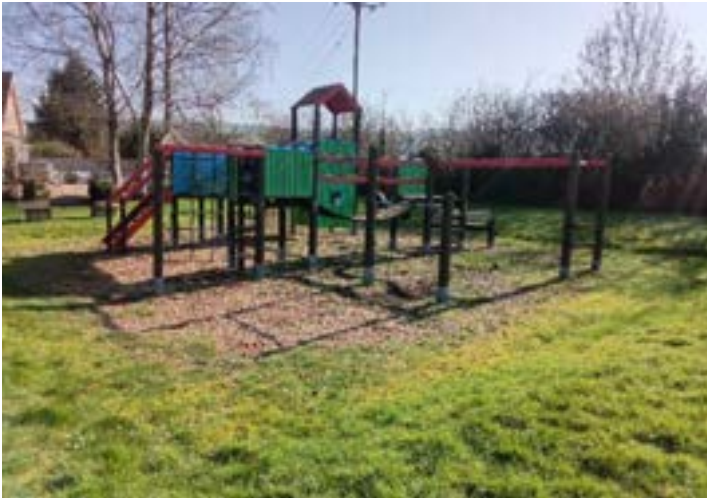
**Item:** Activity Equipment - Multi Play (Junior)  
**Manufacturer:** Not Identified

**Finding:** The depth of the loose fill surfacing is lower than the recommended depth specified in BS EN 1176; the free height of fall of the equipment is less than 2.0m and a minimum of 300mm depth should be provided (including an extra 100mm to allow for compaction and displacement as per BS EN 1176 Part 1 - Table 4)

**Action:** Top up loose fill surfacing to recommended levels

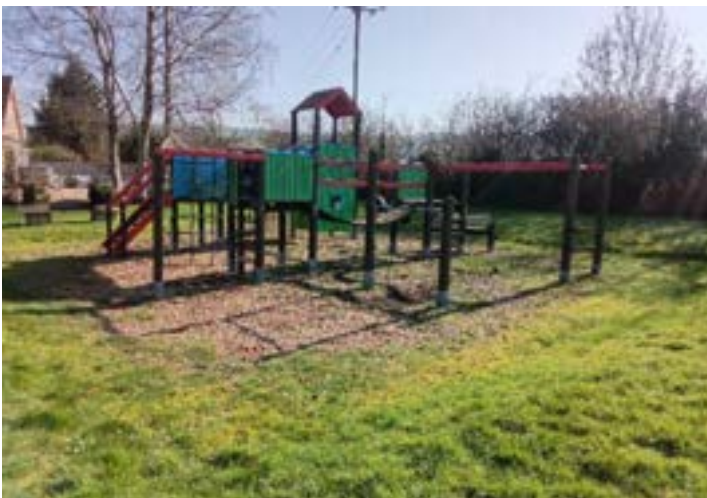
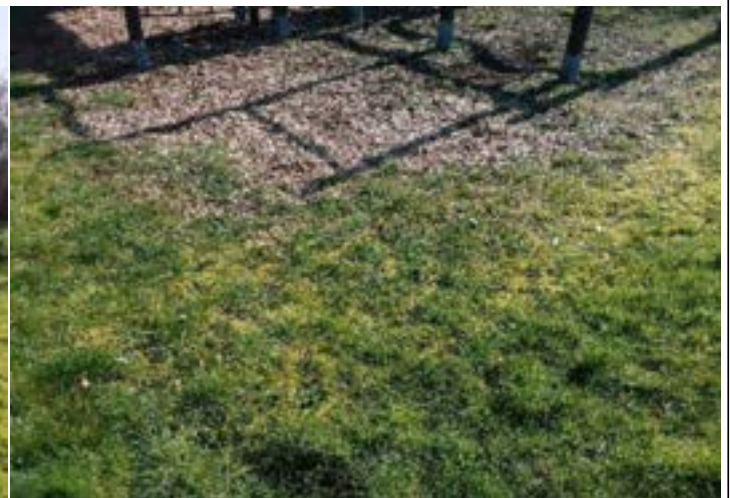
**Item:** Activity Equipment - Multi Play (Junior)  
**Manufacturer:** Not Identified

**Finding:** There is weed / vegetation growth within the surface

**Action:** Remove weed / vegetation growth

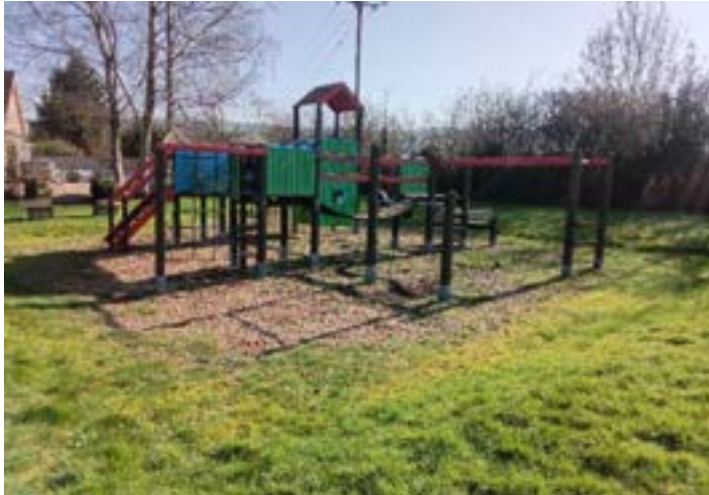
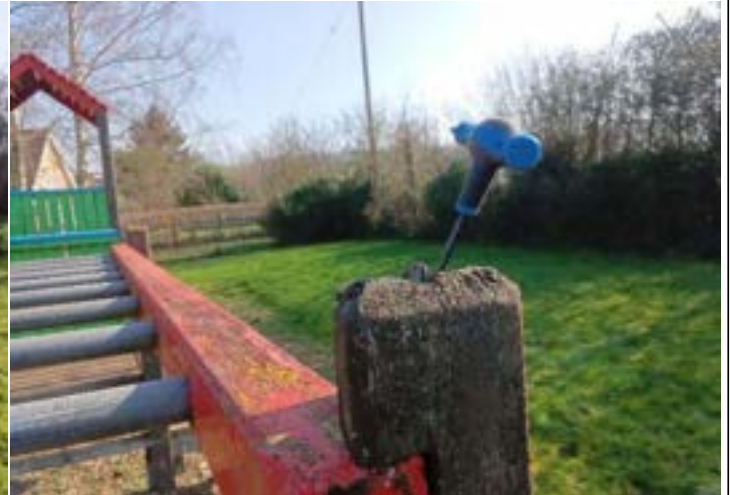
**Item:** Activity Equipment - Multi Play (Junior)  
**Manufacturer:** Not Identified

**Finding:** There are areas or parts of the posts x2 on the monkey bars that have rotted

**Action:** Replace all affected timbers

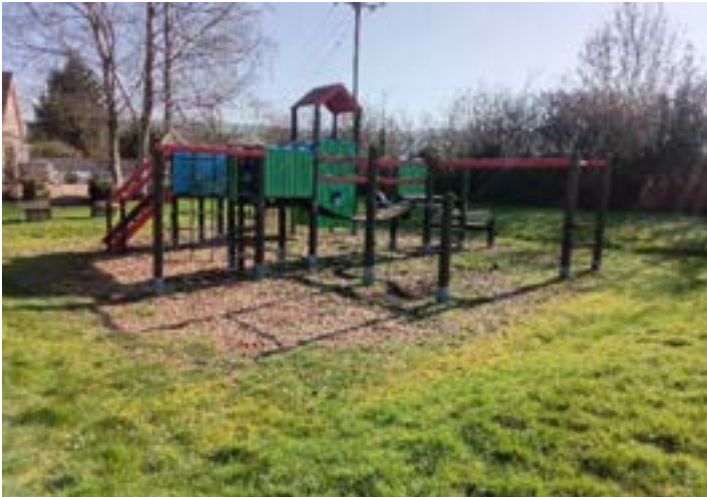
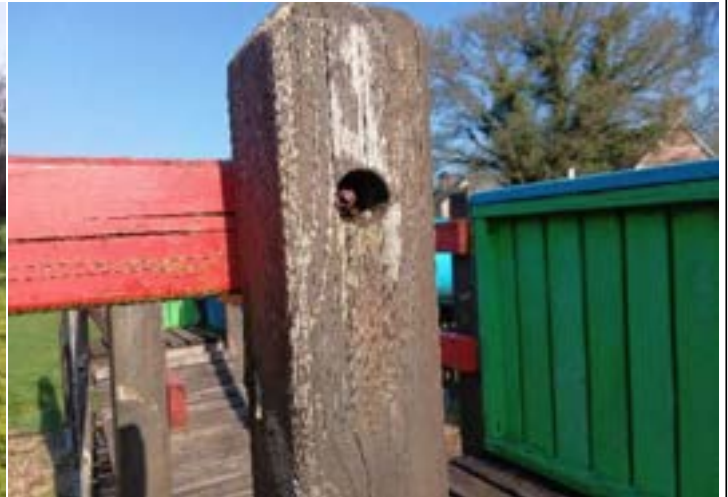
**Item:** Activity Equipment - Multi Play (Junior)  
**Manufacturer:** Not Identified

**Finding:** Bolt cap cover/s missing or damaged

**Action:** Replace

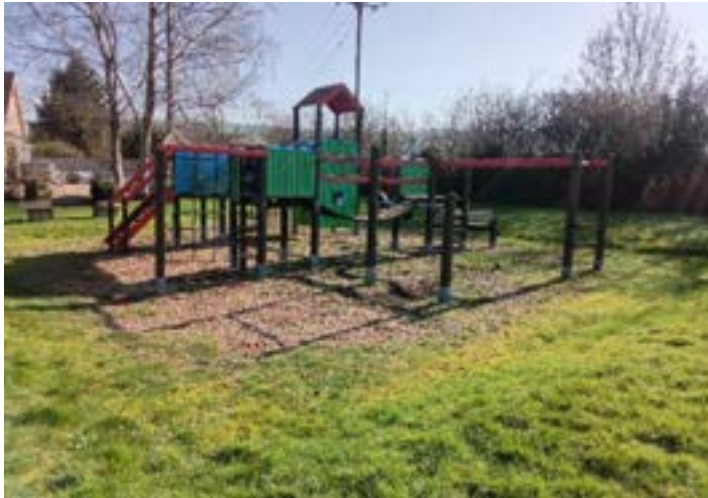
**Item:** Activity Equipment - Multi Play (Junior)  
**Manufacturer:** Not Identified

**Finding:** There is some notable evidence of chain wear

**Action:** Monitor for any further deterioration and replace when 40% worn

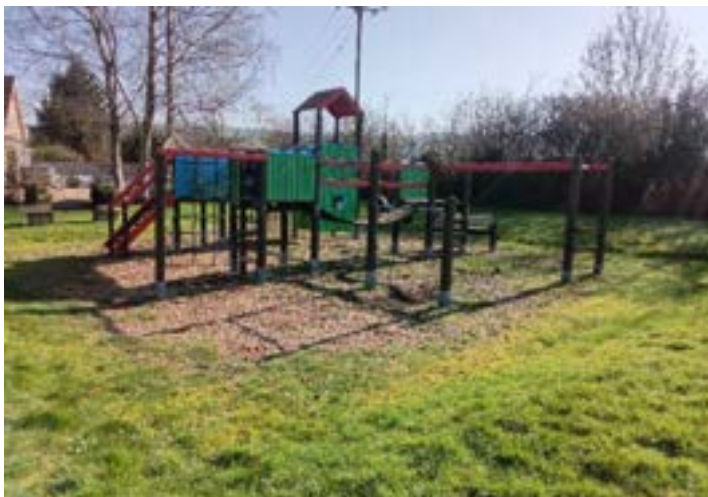
**Item:** Activity Equipment - Multi Play (Junior)  
**Manufacturer:** Not Identified

**Finding:** The connecting lugs are showing signs of wear

**Action:** Monitor for any further deterioration and repair as required

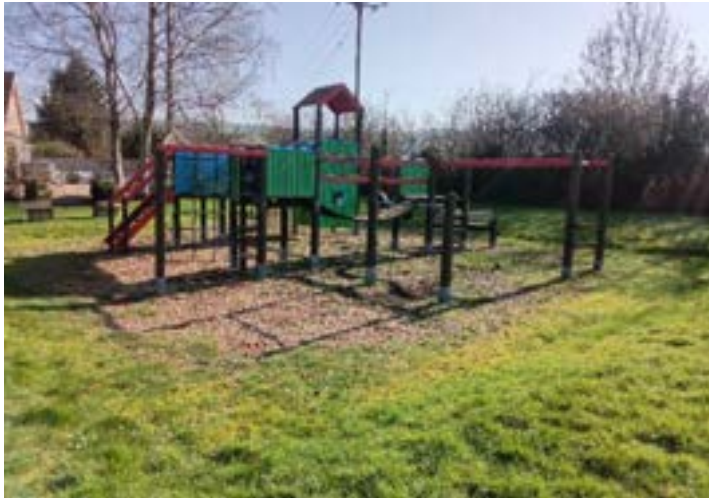
**Item:** Activity Equipment - Multi Play (Junior)  
**Manufacturer:** Not Identified

**Finding:** The shackles have corroded excessively

**Action:** Replace

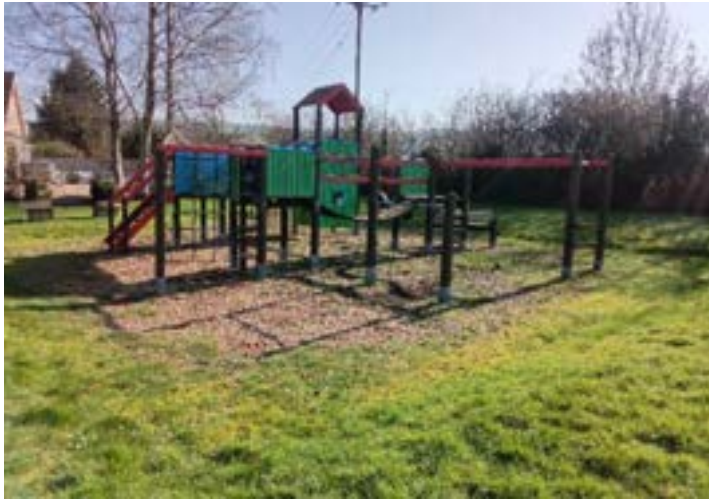
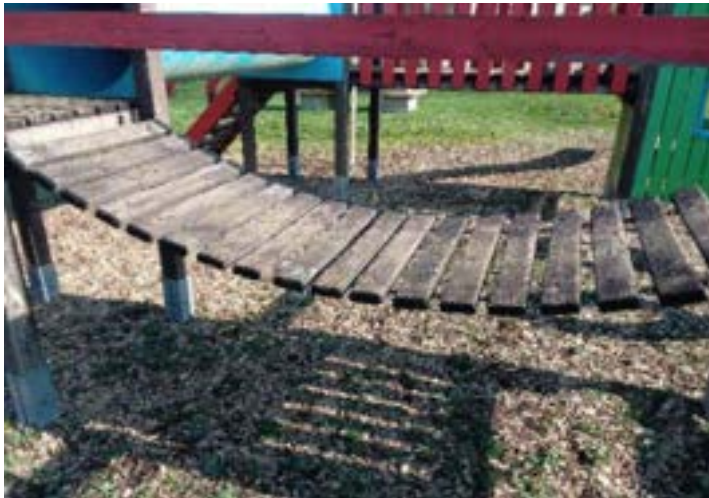
**Item:** Activity Equipment - Multi Play (Junior)  
**Manufacturer:** Not Identified

**Finding:** The shackles are worn in excess of 40% and require renewing

**Action:** Replace worn shackles

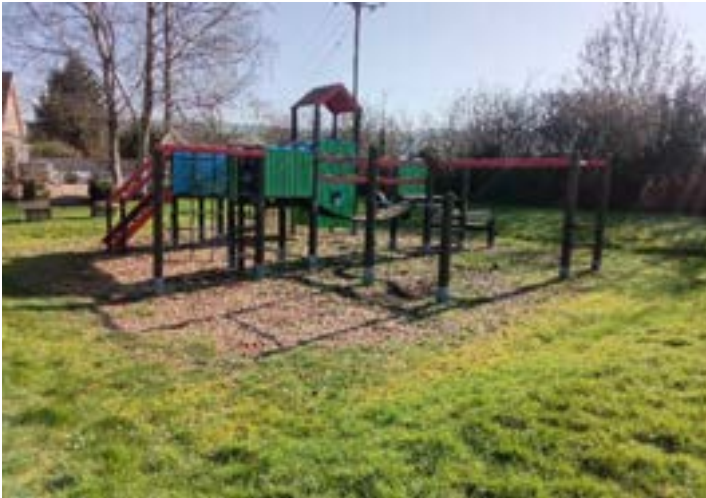
**Item:** Activity Equipment - Multi Play (Junior)  
**Manufacturer:** Not Identified

**Finding:** There is some evidence of rot in the platforms

**Action:** Monitor for any further deterioration and replace as required

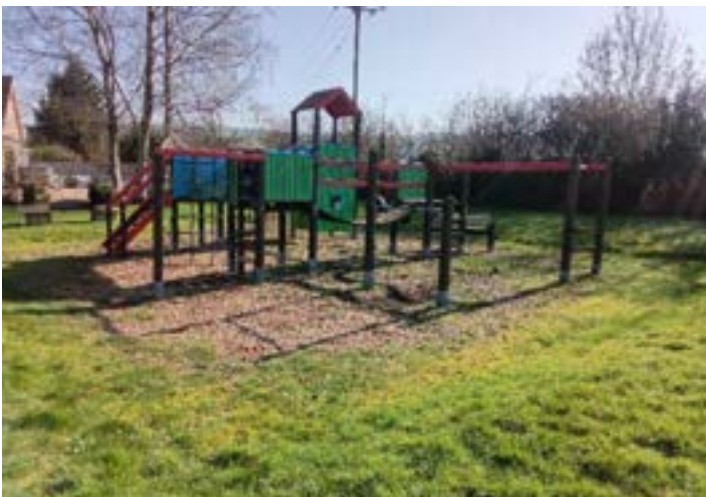
**Item:** Activity Equipment - Multi Play (Junior)  
**Manufacturer:** Not Identified

**Finding:** There is some wear to the chain bars

**Action:** Monitor for any further deterioration and replace when 40% worn

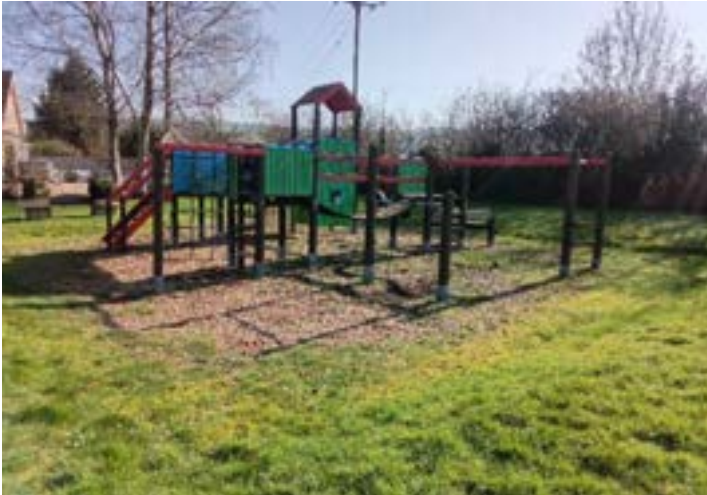
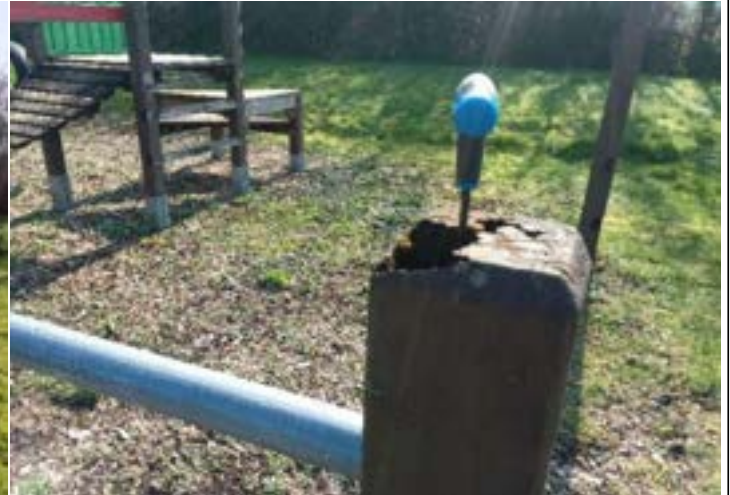
**Item:** Activity Equipment - Multi Play (Junior)  
**Manufacturer:** Not Identified

**Finding:** There are areas or parts of the posts x1 on the somersault bars that have rotted

**Action:** Replace all affected timbers

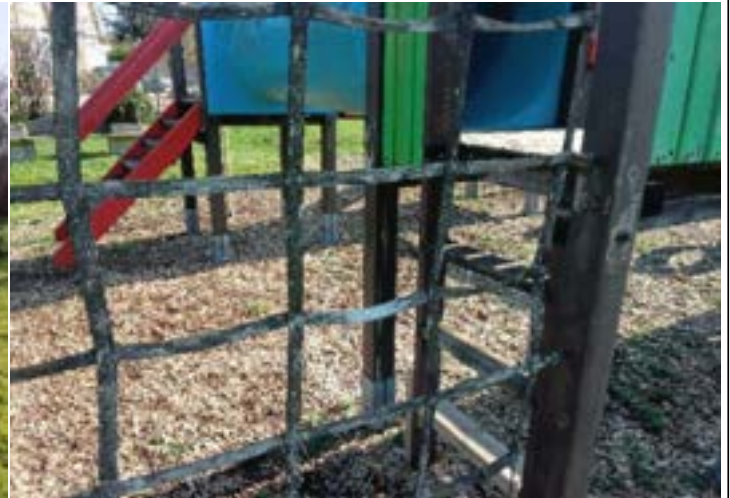
**Item:** Activity Equipment - Multi Play (Junior)  
**Manufacturer:** Not Identified

**Finding:** There is algae or moss on the surface of the equipment

**Action:** Clean and treat appropriately

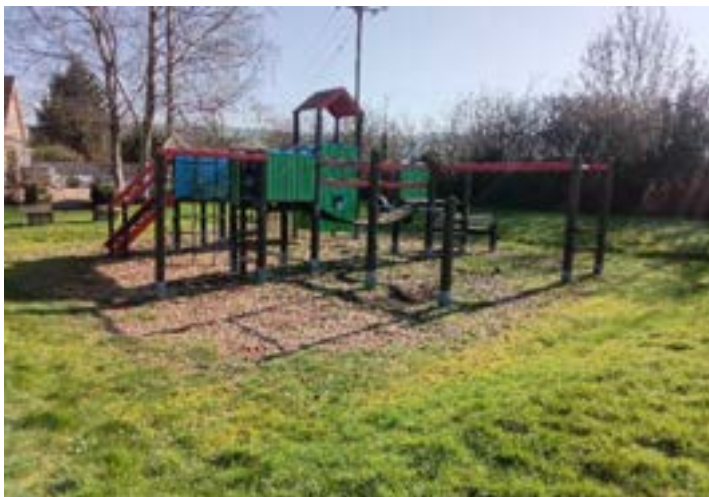
**Item:** Activity Equipment - Multi Play (Junior)  
**Manufacturer:** Not Identified

**Finding:** A number of net fixing(s) have worked loose

**Action:** Secure all loose fixings

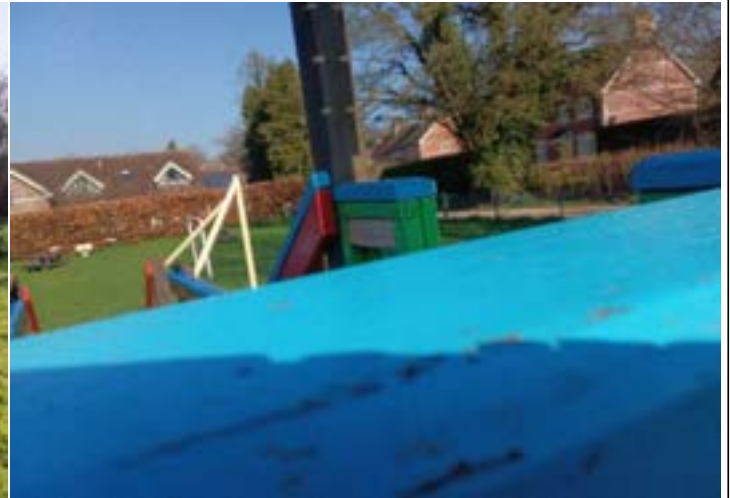
**Item:** Activity Equipment - Multi Play (Junior)  
**Manufacturer:** Not Identified

**Finding:** The top of the barrier may encourage standing or sitting, in contravention of the requirements of BS EN 1176 Part 1

**Action:** Monitor - No action given the risk assessment

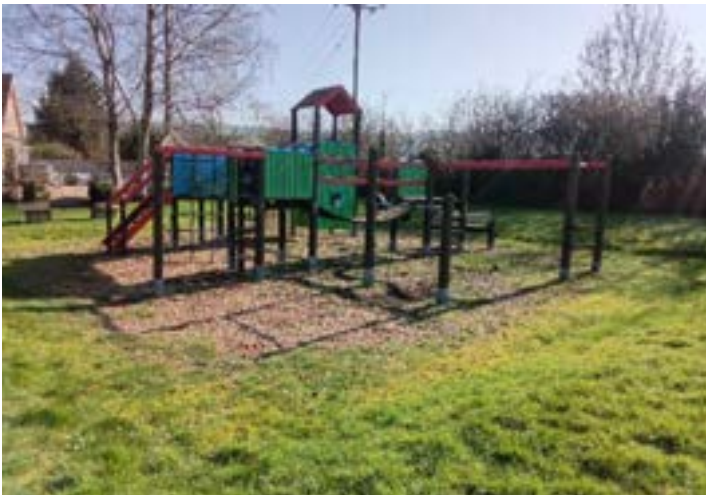
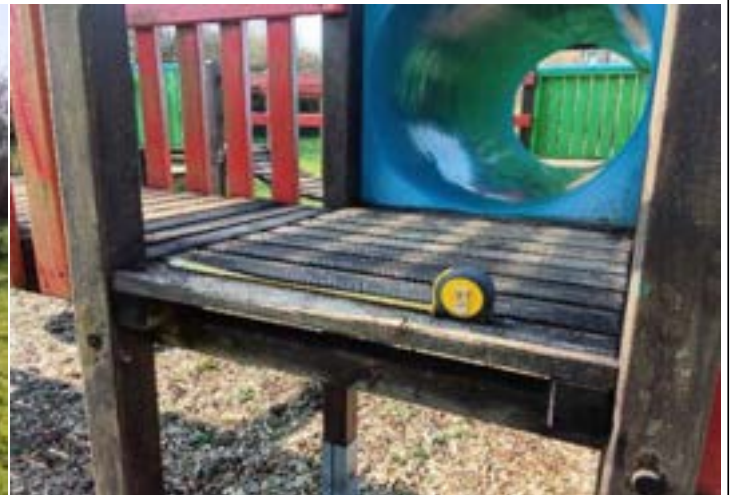
**Item:** Activity Equipment - Multi Play (Junior)  
**Manufacturer:** Not Identified

**Finding:** There is an opening in the barriers exceeding the width allowed (500mm) in BS EN 1176 Part 1

**Action:** Monitor - No action given the risk assessment

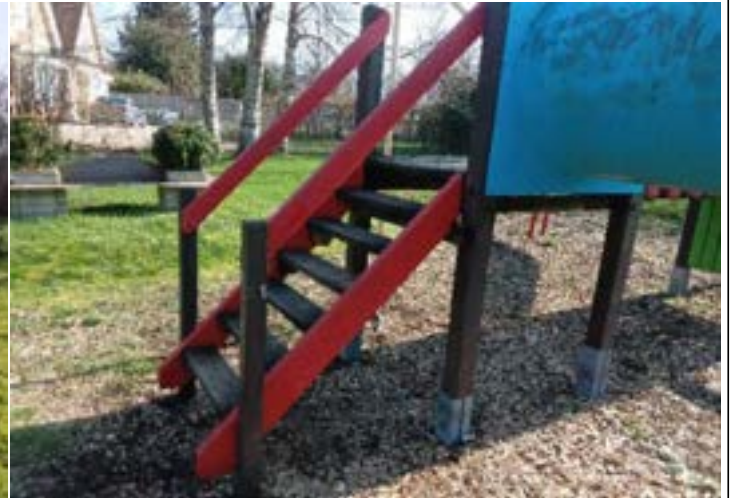
**Item:** Activity Equipment - Multi Play (Junior)  
**Manufacturer:** Not Identified

**Finding:** There is insufficient guarding on the stairs leading up to the platform that exceeds 1m in height, in contravention of the requirements on BS EN 1176 Part 1

**Action:** Monitor - No action given the risk assessment

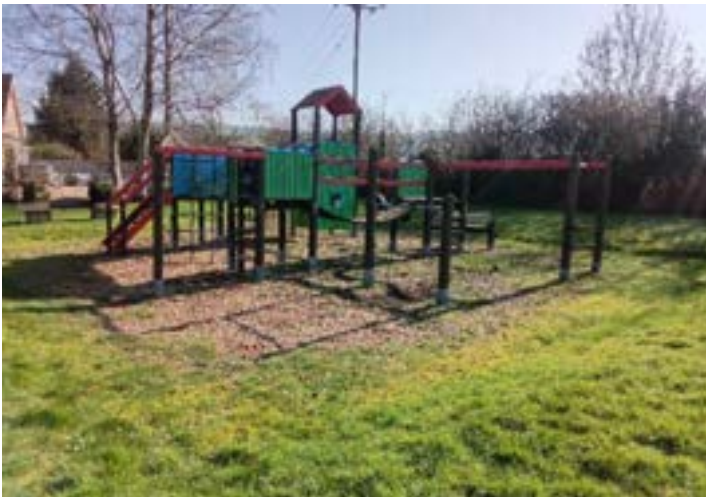
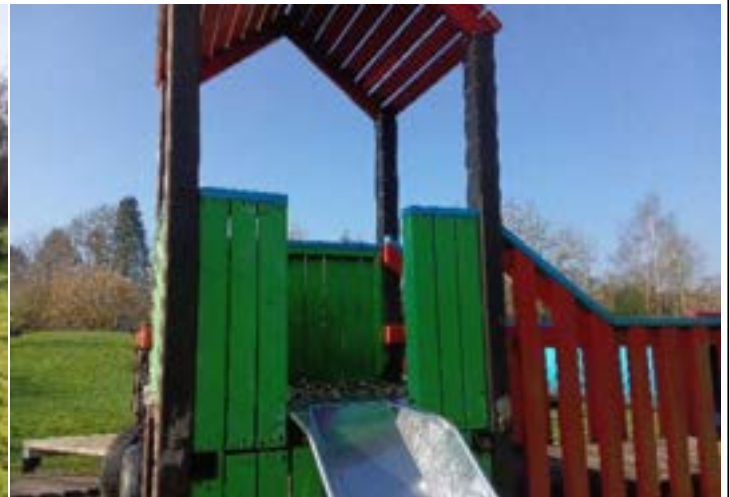
**Item:** Activity Equipment - Multi Play (Junior)  
**Manufacturer:** Not Identified

**Finding:** This item has no slide bar fitted as required by BS EN 1176 Part 3

**Action:** Monitor - No action given the risk assessment

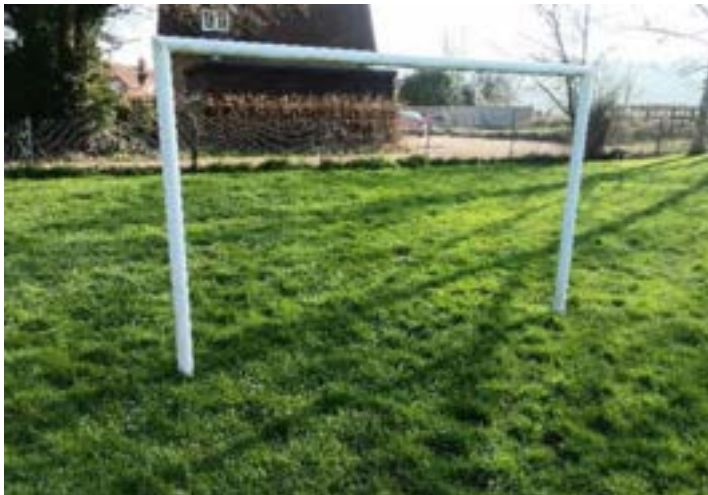
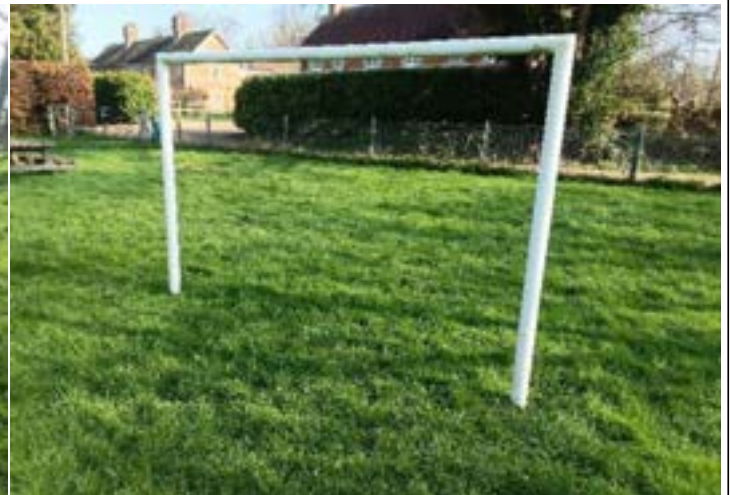
**Item:** Multi Use Games Area - 5 a side Goals  
**Manufacturer:** Not Identified

**Finding:** NB: We have undertaken a maintenance inspection only of the football goal(s); full load testing falls outside the scope of our inspection.

**Action:** Implement load testing as required
